September 7, 2017

Property: Taylor-French House  
970 Whittier Highway  
Moultonborough, NH 03254

At your request, an engineering consultation regarding the above property was performed on August 3, 2017. The primary purpose of the inspection and this report is to assess the general condition of the existing structure of the Taylor-French House.

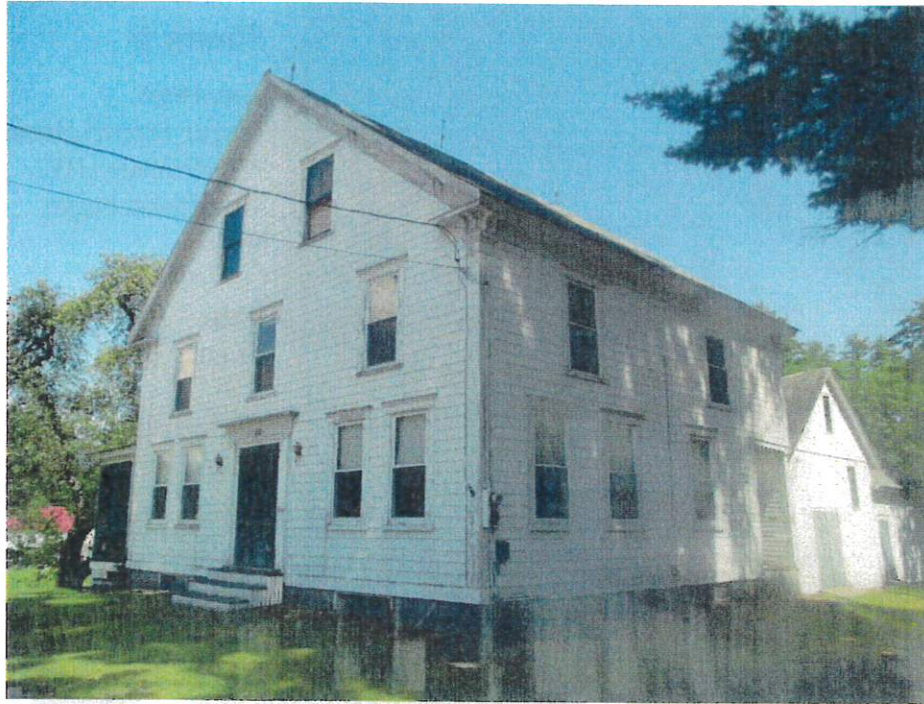
**Photo: 1**

The Taylor-French House (Photo 1) is a historic 19<sup>th</sup> century building owned by the Town of Moultonborough. As we understand it, the Town is performing a general study of the building to decide its potential future use. Sheerr McCrystal Palson (SMP) Architecture is preparing a "Historic Building Assessment" (draft dated July 18, 2017) that includes discussion of the existing architectural features, building systems, and envelope. We understand that architectural historian, Dr. James Garvin of Concord, NH, has provided a preliminary report of the historical and architectural significance of the property. Team Engineering is responsible for the assessment of the general condition of the existing building structure.

**Description:**  
Main House  
Southwest Elevation;  
West being Front

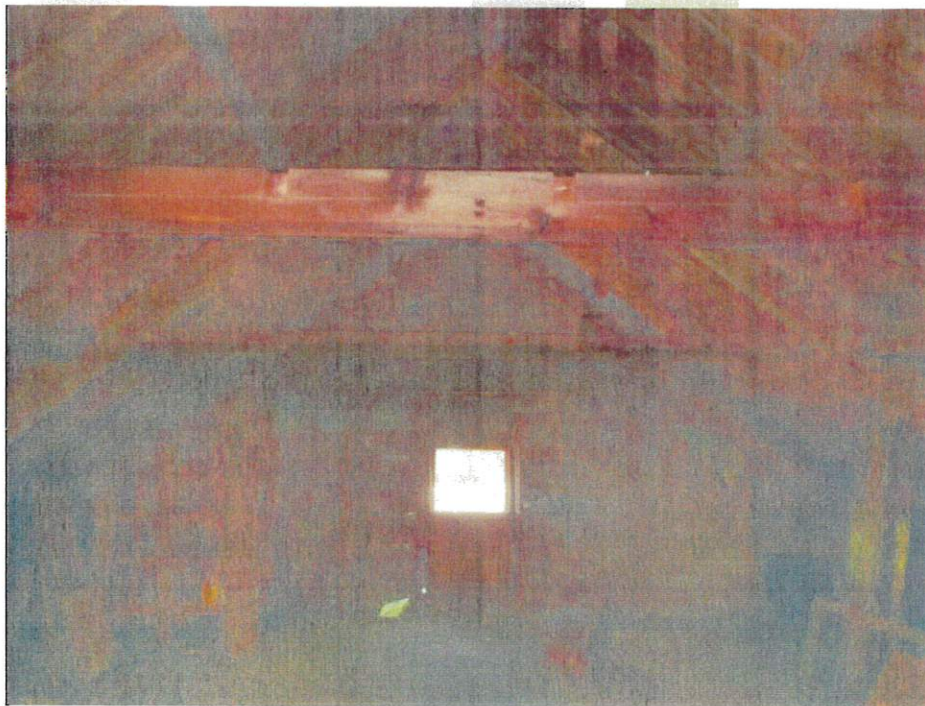
**Photo: 6**

It appears that the main house was originally constructed using a timber post and beam framing system (Photo 6). This was observed in the roof/attic framing where 6"x8" timber rafters are spaced approximately 8 feet on center. These rafters span approximately 12 feet horizontally in the east-to-west direction and are at an approximate 10V:12H pitch. There are 4"x4" purlins connected into the roof beams spaced approximately 3 feet on center horizontally spanning north-to-south. We observed collar ties (4"x5") at rafter locations just above mid-height of the gable triangle for the attic space.

**Description:**  
Post & Beam Roof  
Framing for Main  
House

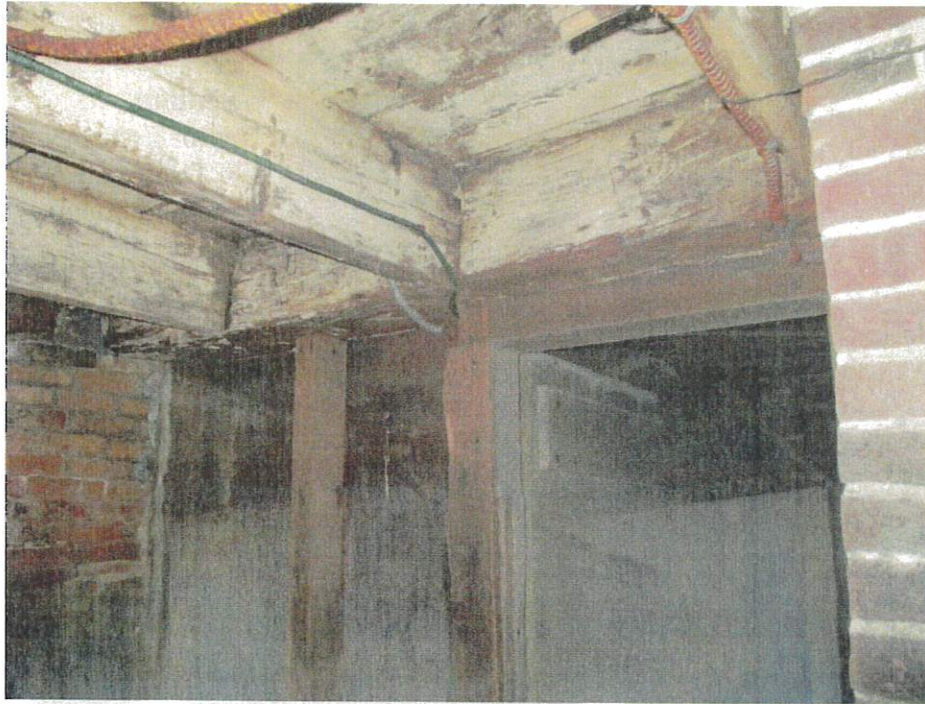
**Photo: 9**

We viewed the first-floor framing through access points in the timber plank along the basement ceiling. The main load-carrying timber floor beam is 5"x8" through majority of the basement. There was a small room along the southeast corner where the timber beam is 8"x8" (Photo 9).

**Description:**  
Southeast Section of  
First Floor Framing  
of Main House

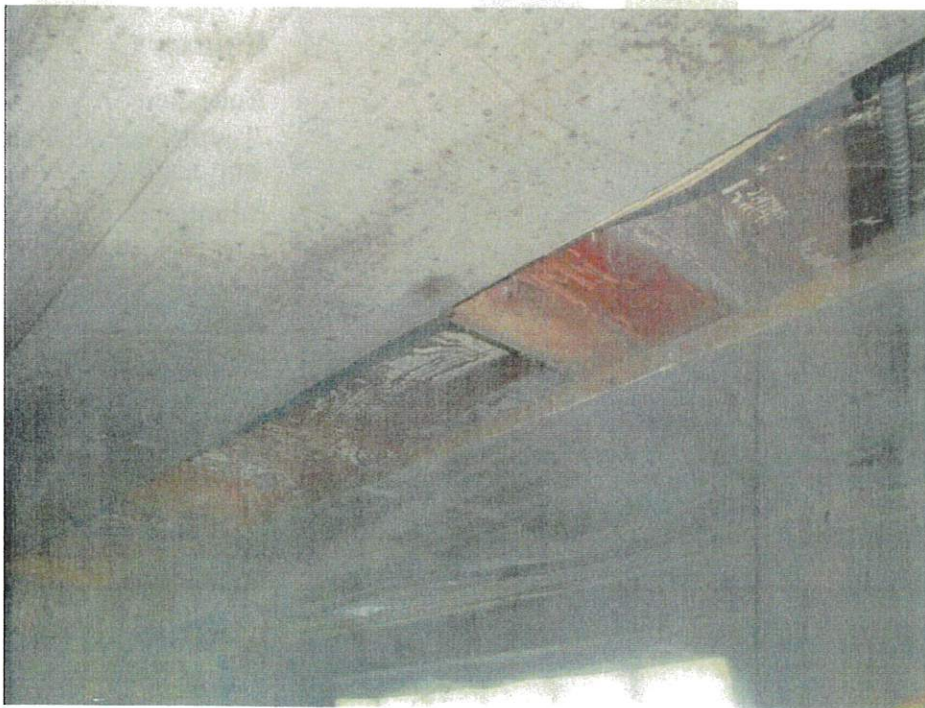
**Photo: 10**

The majority of first-floor joists (visible from the basement) are (2) 3"x5" timbers spaced 24" on-center, spanning approximately 12 feet (Photo 10). These appear to be newer than the main floor beams and might have been installed to help strengthen the floor by reducing the tributary widths of generously spaced members. In the small room along the southeast corner, the joists are 2"x8" timbers spaced 24" on-center (Photo 9).

**Description:**  
First Floor Framing  
of Main House

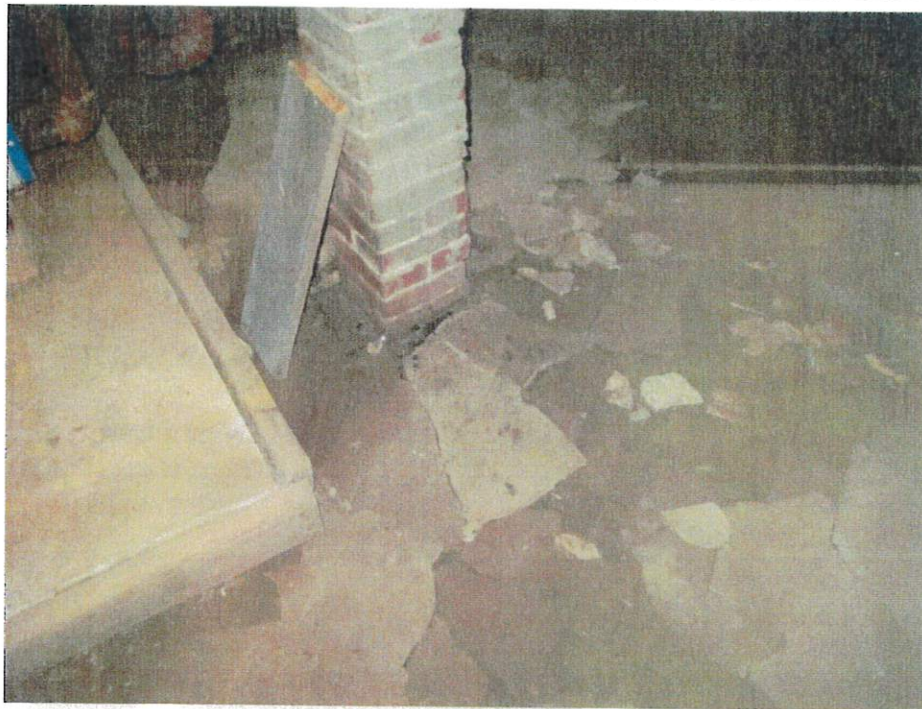
**Photo: 13**

**Description:**  
Heavy deterioration  
of main house  
basement concrete  
floor slab

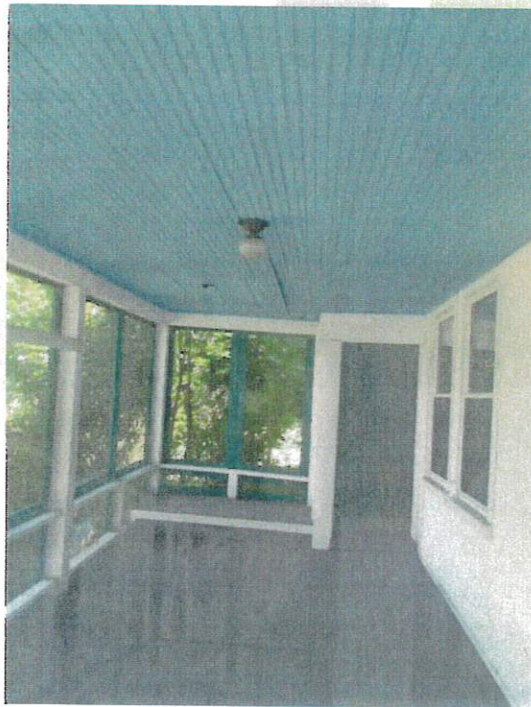
**Photo: 14**

The main house porch roof framing (Photo 14) consists of 2"x6" timber rafters spaced 24" on-center and spanning north-to-south approximately 10 feet. These rafters appear to sit on a 4"x6" timber beam covered in white trim.

**Description:**  
Main House Porch  
Interior

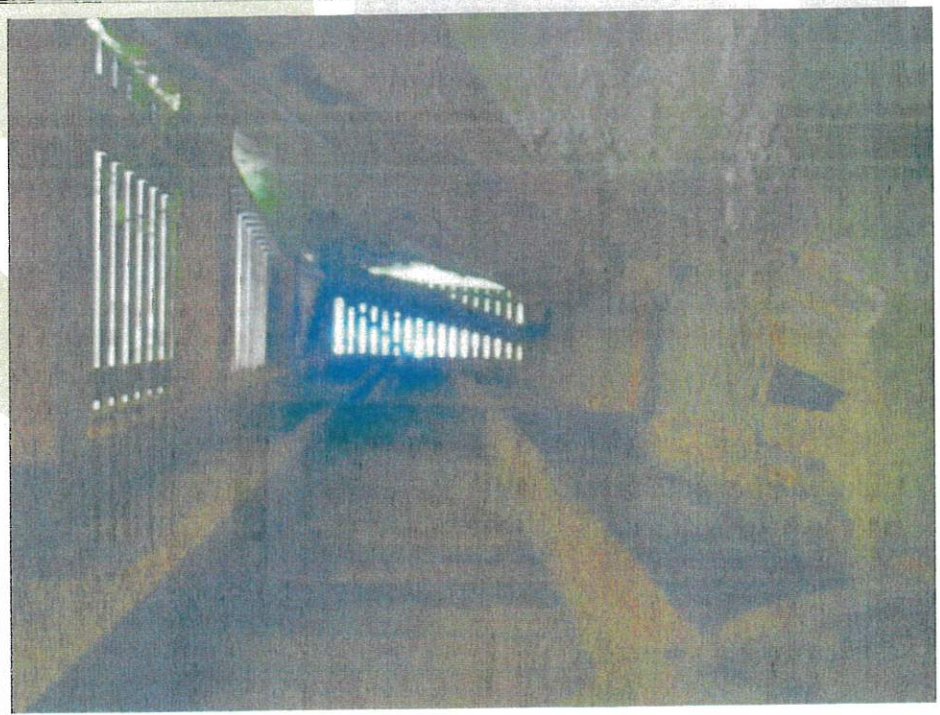
Photo: 15

The floor framing consists of 2"x6" timber joists spanning in the east-to-west direction at 24" on-center (Photo 15). A flush-framed 2"x6" timber beam shortens the span of the porch floor joists, and is supported by a short 5"x5" timber post.

Main House Porch  
Floor Framing

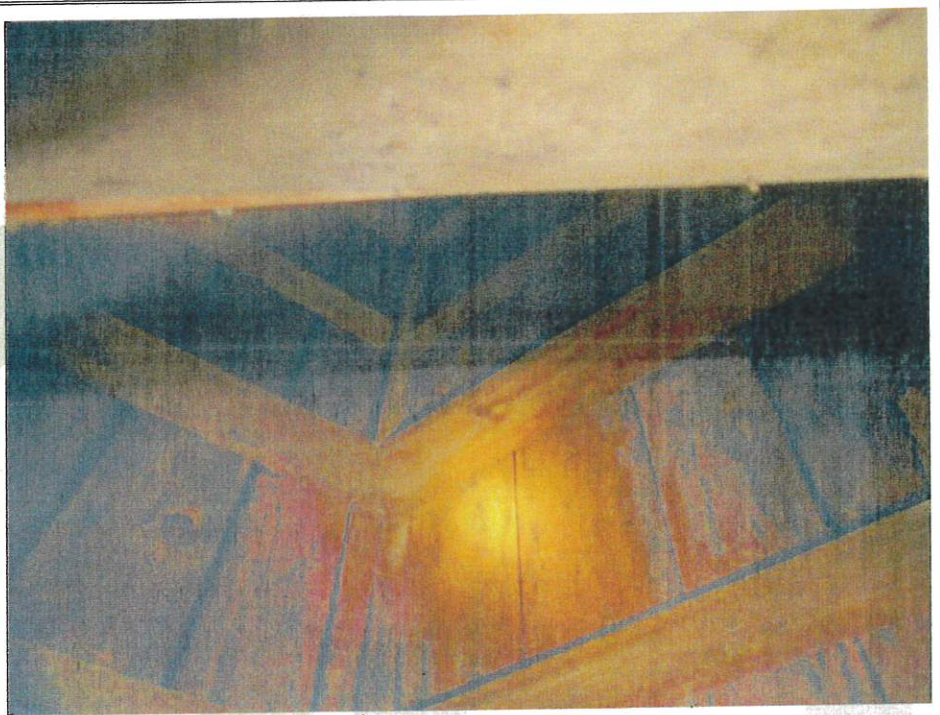
Photo: 16

The roof for this portion of the building appears to be 2"x8" timber rafters spaced 24" on-center (Photo 16). We viewed them through a small ceiling opening above the barn stairs that was not accessible to hand measure. At the roof overlay near the barn, the framing is 2"x4" timber rafters spaced 24" on center.

Main House-to-Barn  
Connector Roof  
Framing

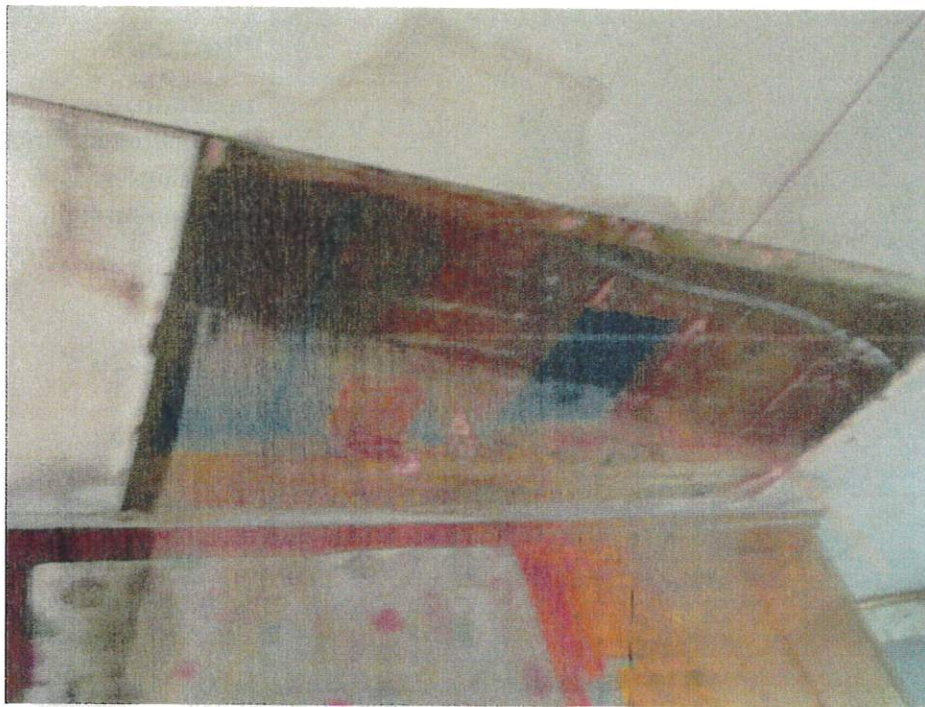
**Photo: 17**

In the east kitchen (over the basement), the second-floor joists span like the main home in the east-to-west direction at an approximate 14-foot span (Photo 17). We observed staining and deterioration of the ceiling finishes that appears to be caused by rodent excrement (Photo 18). This was discovered when a ceiling tile was removed to access the framing.

**Description:**  
Main House-to-Barn  
Connector; East  
Kitchen Second  
Floor Framing  
Access

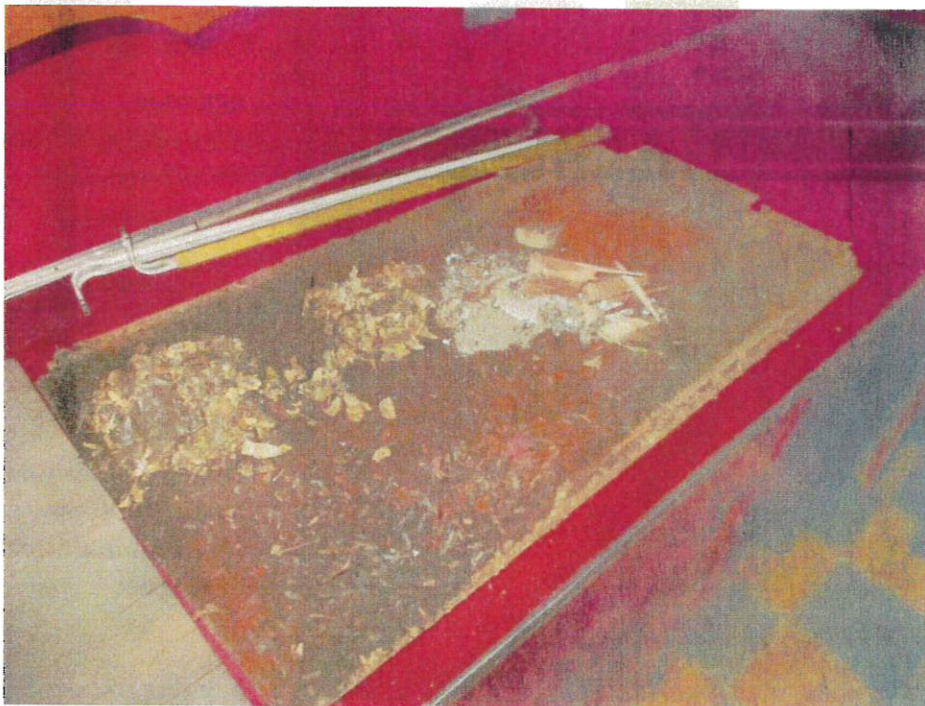
**Photo: 18**

**Description:**  
Main House-to-Barn  
Connector; Rodent  
Droppings above  
Removed Ceiling  
Tile

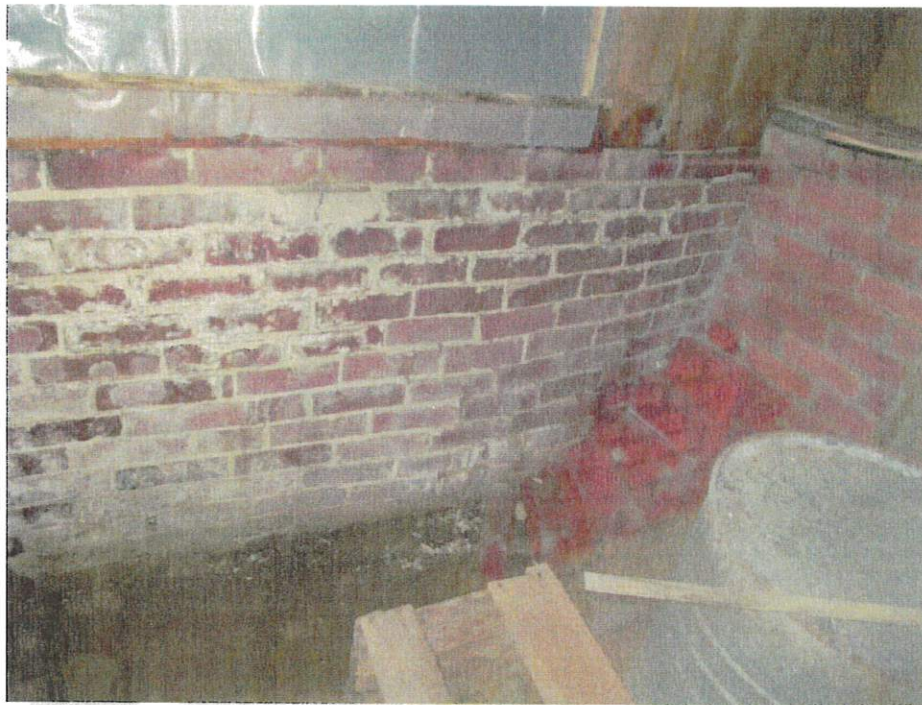
**Photo: 21**

The condition of the east kitchen basement slab is similar to that in the main house basement with severe deterioration observed. There was a significant bulge along the bottom of the brick stem wall in this basement (Photo 21). It appeared that tree roots from the overgrown exterior landscaping adjacent to the building may have caused this bulge (Photo 22), but it could also be the result of excessive and/or sustained lateral earth pressures from the backfill it retains.

**Description:**  
Main House-to-Barn  
Connector; Brick  
Foundation Wall  
Bulge

2. Repair bulging foundation wall in east kitchen basement of main home. This wall appears to be bulging in due the overgrown landscaping and sapling trees grown in adjacent to this area and/or excessive lateral earth pressures. Removing the trees, pruning back ornamentals (lilacs) and installing a new foundation wall will address this failing portion.

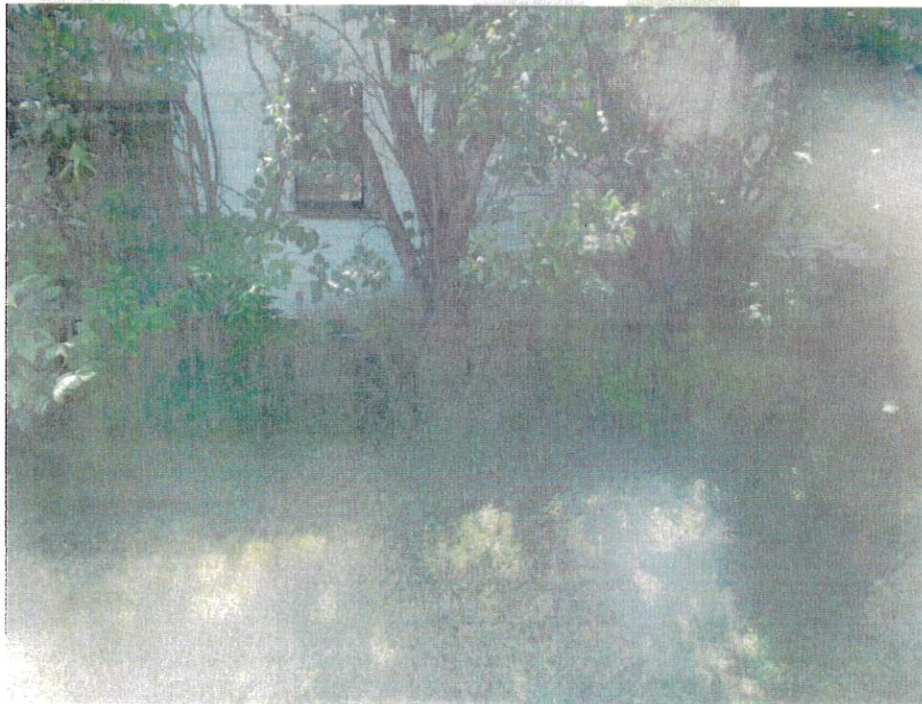
**Photo: 22**

**Description:**  
Main House-to-Barn  
Connector;  
Landscape Trees  
located on Opposite  
side of Brick Wall  
Bulge

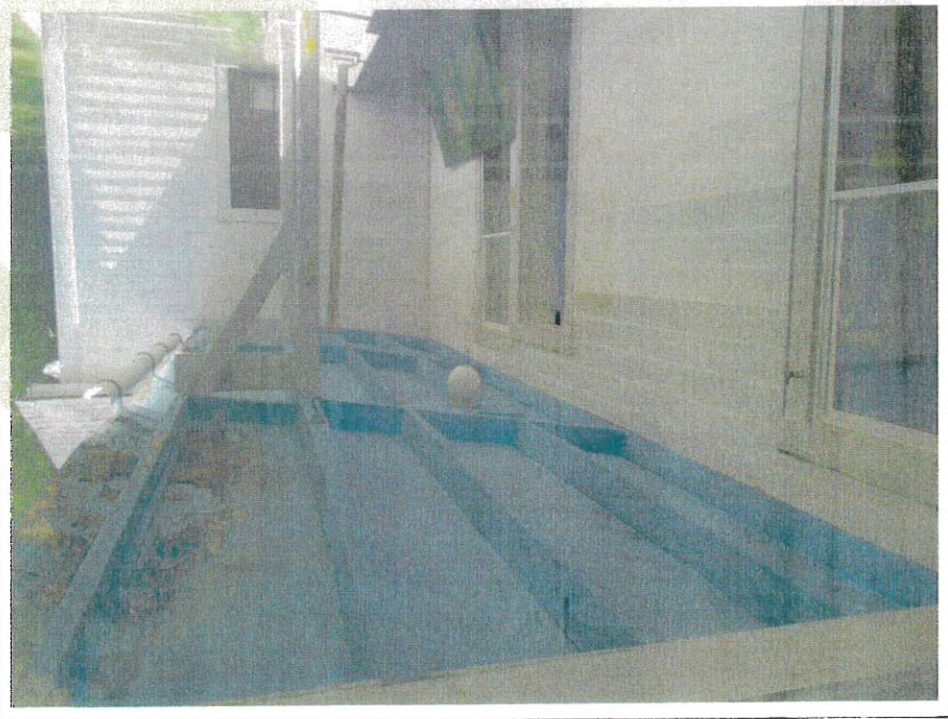
The south-facing porch is the kitchen entry for the building. The roof is framed with 2"x5" timber purlins spaced 20" on-center with 2"x5" timber beams supported by timber posts (Photo 23). The floor framing for this area is largely inaccessible, but it appears that timber floor joists span east-to-west.

Photo: 23  
Location: Taylor-French House  
970 Whittier HW  
Moultonborough, NH  
Date: August 3, 2017  
Description: Main House-to-Barn Connector Porch; South Facing Porch

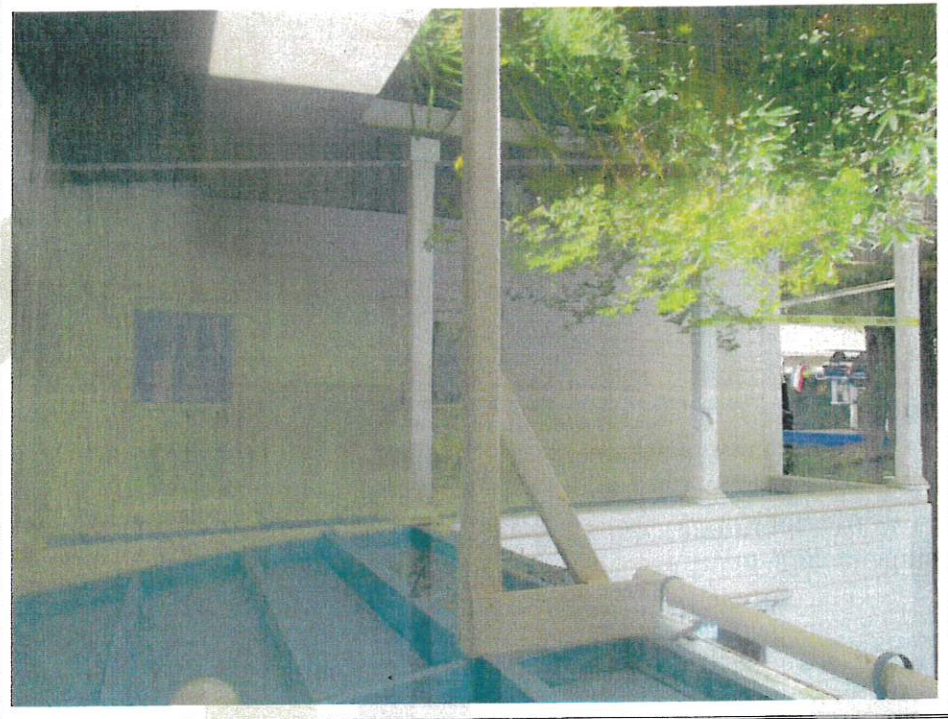
The ceiling of the east-facing porch is the expanded second floor above (Photo 24). That floor is framed with 2"x6" timbers spaced 16" on-center bearing on what appeared to be a 6"x10" timber drop beam (measured around finished trim) supported with multiple timber posts. The porch floor joists in this area were measured are 2"x7" timbers spaced 16" on-center supported by 6"x6" timber beams.

Photo: 24  
Location: Taylor-French House  
970 Whittier HW  
Moultonborough, NH  
Date: August 3, 2017  
Description: Main House-to-Barn Connector Porch; East Facing Porch

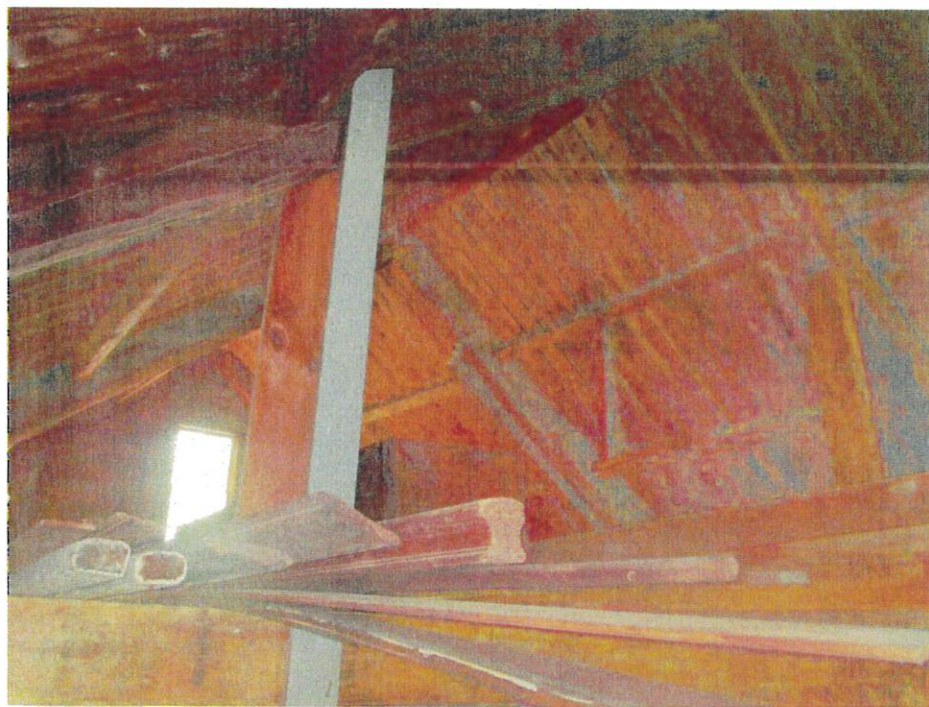
**Photo: 25**

The barn's roof consists of 8"x10" timber rafter beams spaced 8 feet on center with 4"x4" timber purlins spaced 4 feet on-center (Photo 25). There is an 8"x8" timber tie (horizontal) at the bottom of the gable triangle with a center post and a pair of 3/4" metal tension rods, carrying the second-floor framing below (Photo 26). The rafters are supported by 8"x12" timber posts.

**Description:**  
Barn; Post & Beam  
Roof Framing

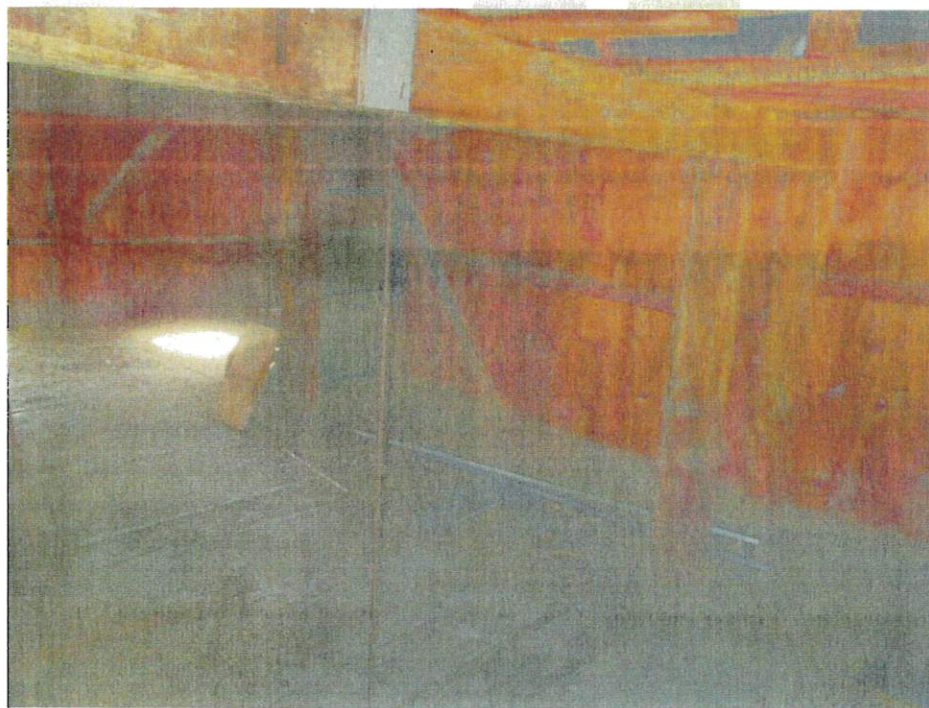
**Photo: 26**

**Description:**  
Barn; Metal tension  
rods in second floor  
framing

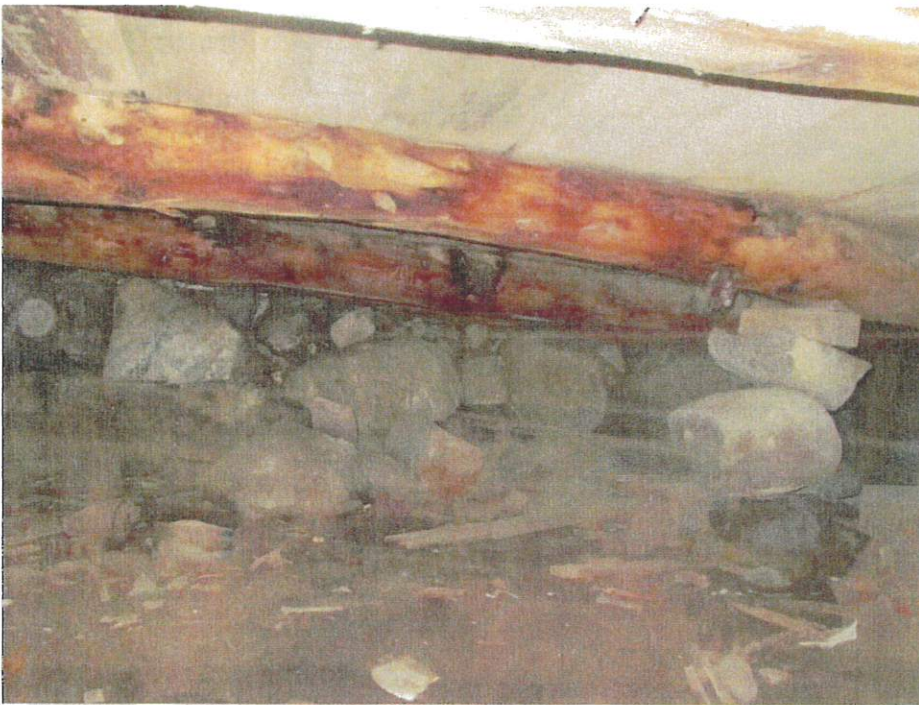
**Photo: 29**

The first-floor framing at the southern portion of the barn consists of two  $\pm 8''$  diameter rough log beams spaced 4 feet on-center (Photo 29). Dry-stacked stones supporting the beams that act as foundation piers are out-of-plumb, obviously structurally inadequate and need correction before the barn is re-occupied.

**Description:**  
Southern First Floor  
Barn Framing from  
Crawlspace

1. Reconstruct the barn foundation and repair and/or strengthen its first-floor framing. The barn's foundation is comprised of stacked stone rocks minimally contacting the building's structure. This means any weight applied to the building (snow, live, dead, etc.) is applied at random points along the foundation and may cause uneven loading. The stacked rocks could easily collapse and cause further damage to the structure above. Additionally, the first-floor framing of the barn has significant structural deficiencies including cracked, warped, and significantly deflecting members. These need to be addressed to avoid further collapse in the future.

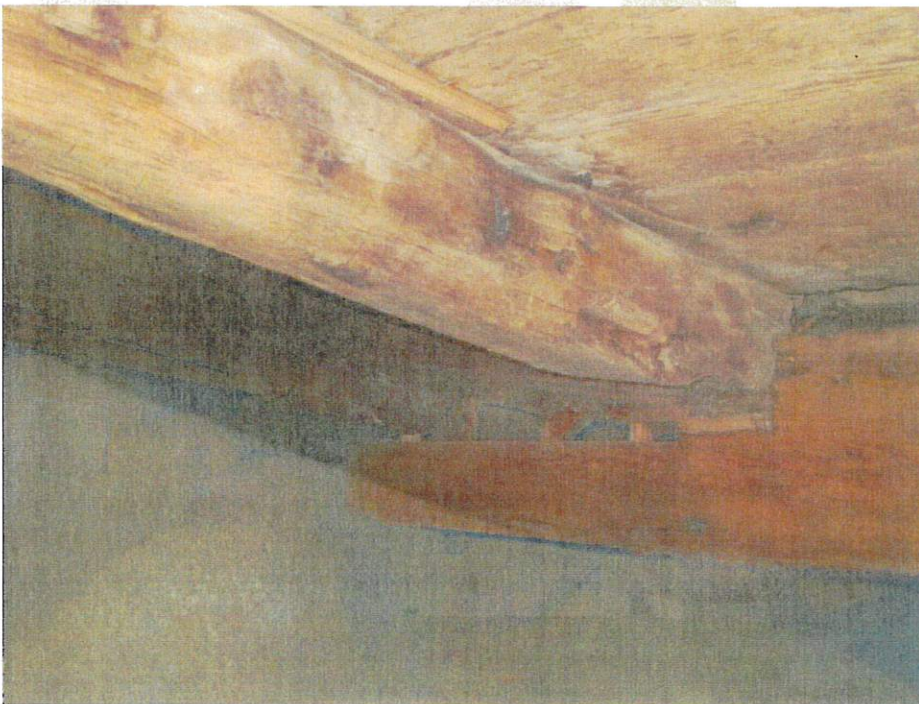
**Photo: 30**

At both portions of the first-floor framing, we observed significant deficiencies in the beams (cracking, sagging, etc.), and improvements are needed immediately (Photos 30-34). As shown in a sketch by SMP Architecture, the “flooring swelling” in the barn is caused by the first-floor framing significantly underperforming causing a beam to deflect up through the floor (Photo 35).

**Description:**  
Barn Failing First  
Floor Framing

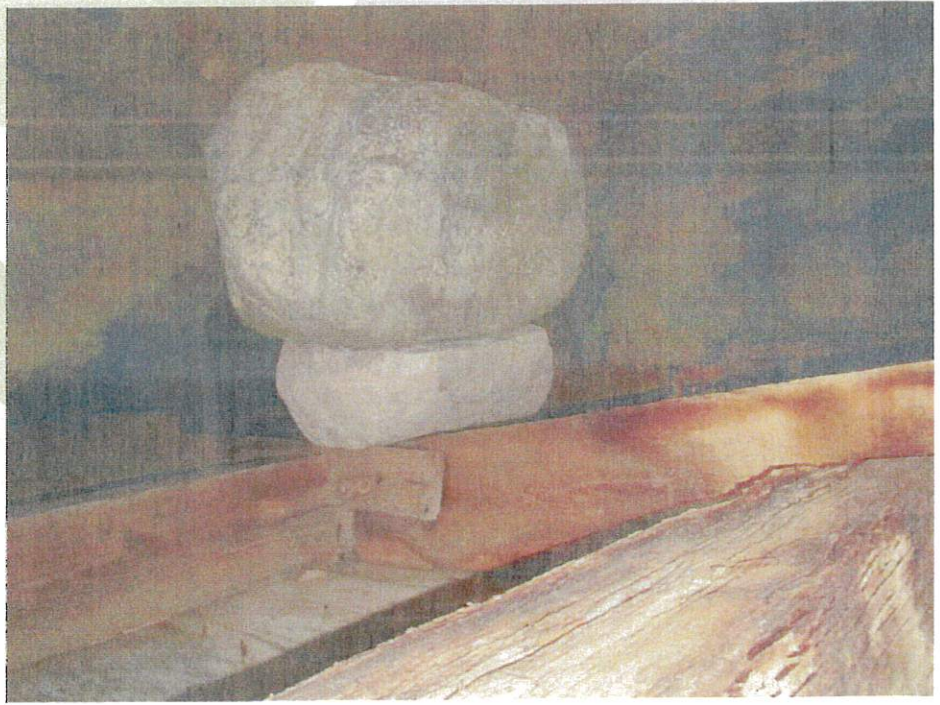
**Photo: 31**  
**Location:**  
 Taylor-French House  
 970 Whittier HW  
 Moultonborough, NH  
**Date:**  
 August 3, 2017  
**Description:**  
 Unbalanced Stacked  
 Rock Post at Barn

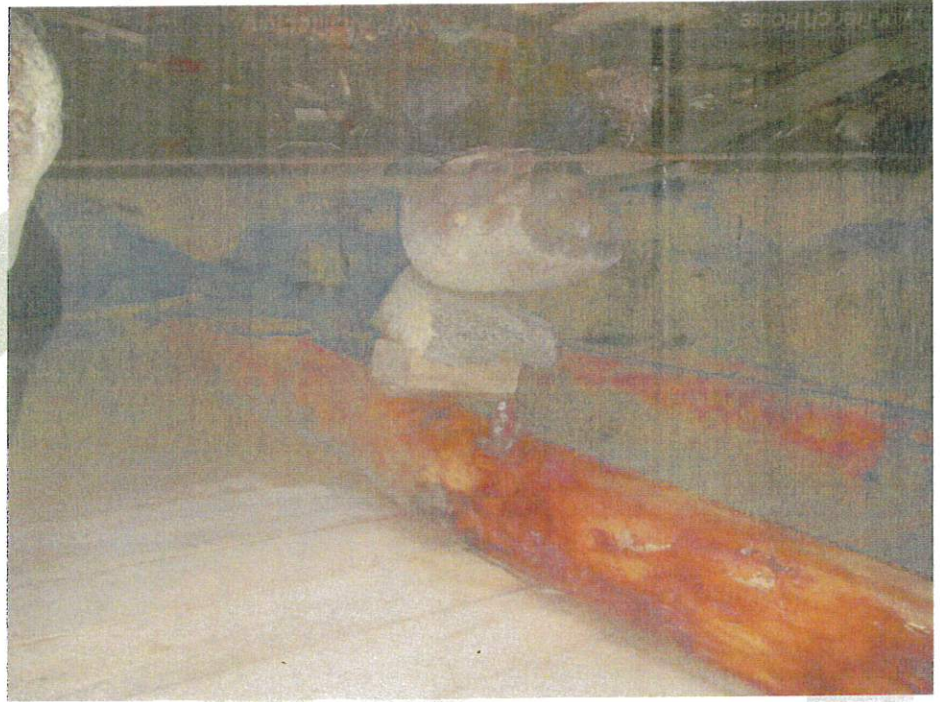
**Photo: 32**  
**Location:**  
 Taylor-French House  
 970 Whittier HW  
 Moultonborough, NH  
**Date:**  
 August 3, 2017  
**Description:**  
 Falling Stacked Rock  
 Post at Barn

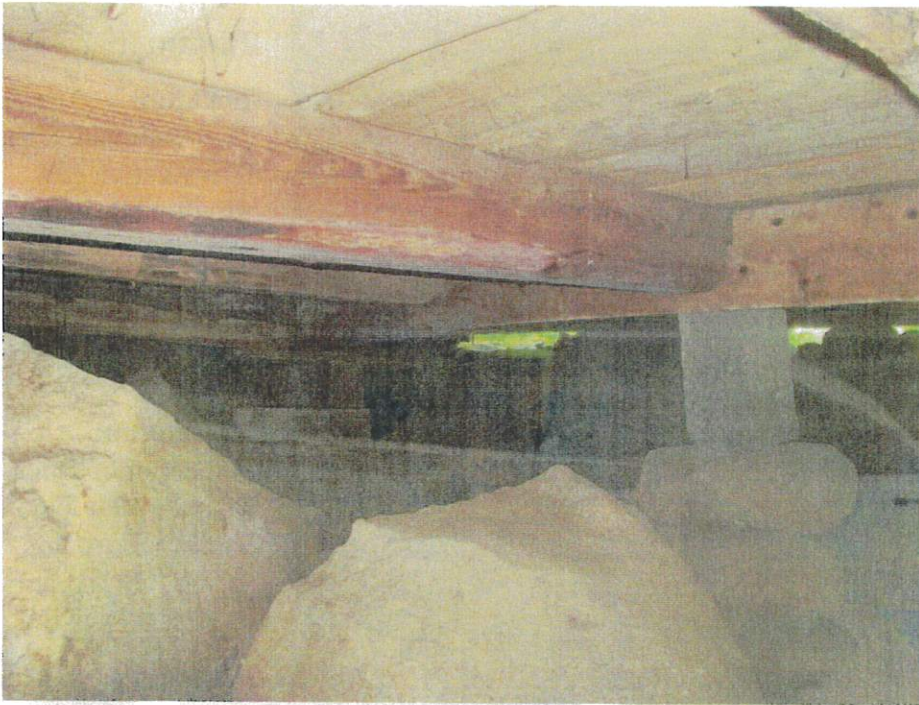
**Photo: 33**

**Description:**  
Unbalanced Stacked  
Rock/Timber Post at  
Barn

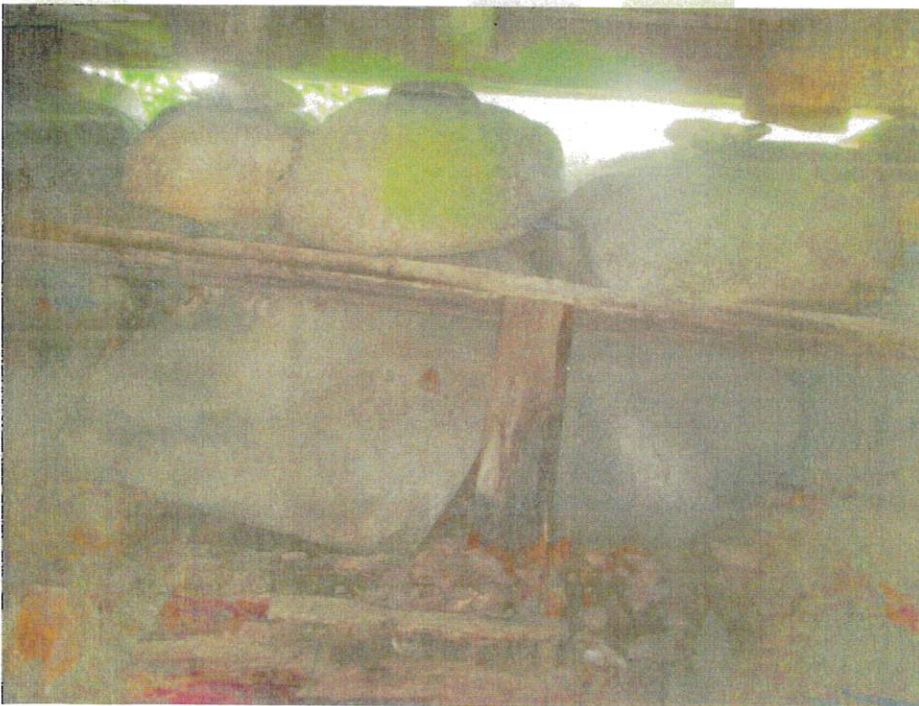
**Photo: 34**

**Description:**  
Broken Support  
Timber Beam and  
Post at Barn

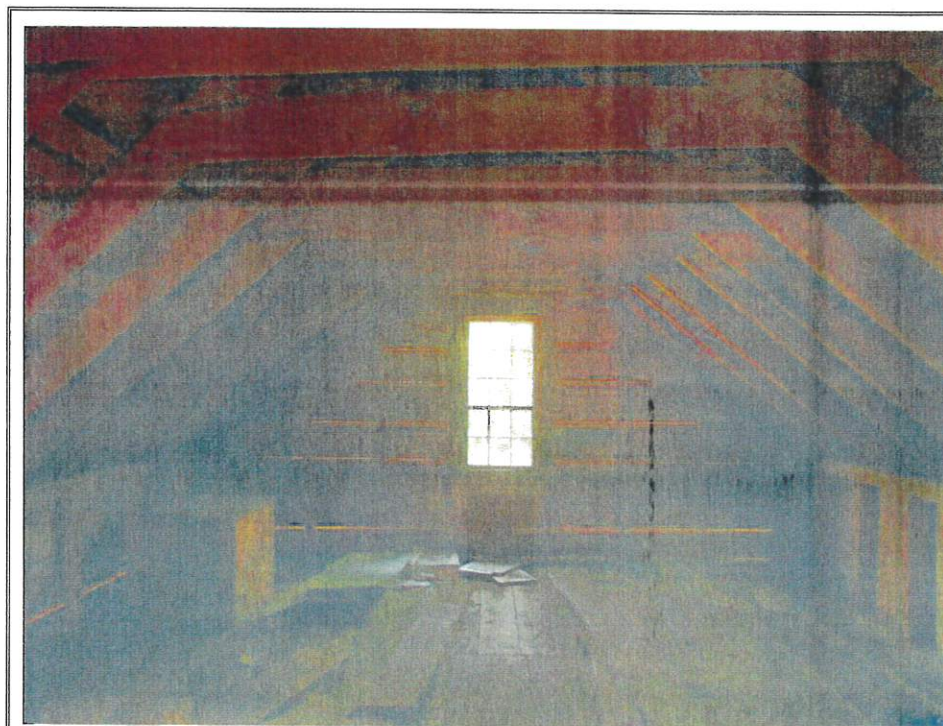
**Photo: 37**

The barn addition appears to have newer framing than the house and original barn. The roof of the barn addition is framed with 2”x6” timber rafters spaced 24” on-center (Photo 37). There is a 1”x7” timber collar tie connected around mid-height of the gable triangle.

**Description:**  
Roof Framing of  
Barn Addition
