# The French-Taylor House

970 Whittier Highway,  
Moultonborough, New Hampshire

## Historic Building Condition Assessment

July 2017/ Revised February 2018

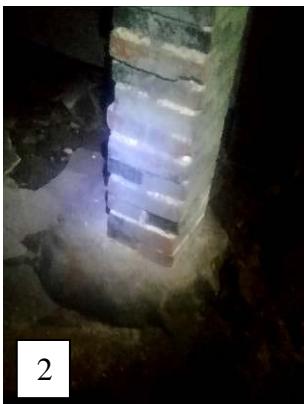
2

In some locations, brick masonry that was added as a finish facing near the top of the foundation has started to come away. It seems likely that the brickwork is contemporary with the c. 1900 modifications. This is because the piers stiffening the main floor, supported on fieldstones, are very similar to the piers supporting the south porch. Brick was also used in the second basement under the kitchen, and likewise appears solid.

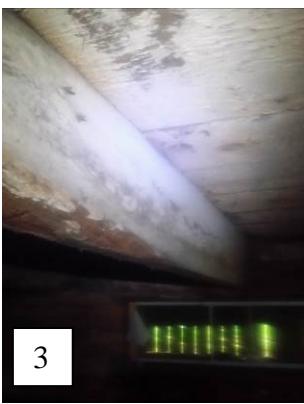
3

In any event, the brick piers are only part of what appears to be an extended 19<sup>th</sup> century effort to shore up the sagging floor above. In addition, there are (earlier?) timber columns and more modern steel columns arranged in a line about mid-span of the floor beams, visible in the southeast corner room. Where exposed, the beams were tested with an awl and appeared solid. Sills were not accessed.

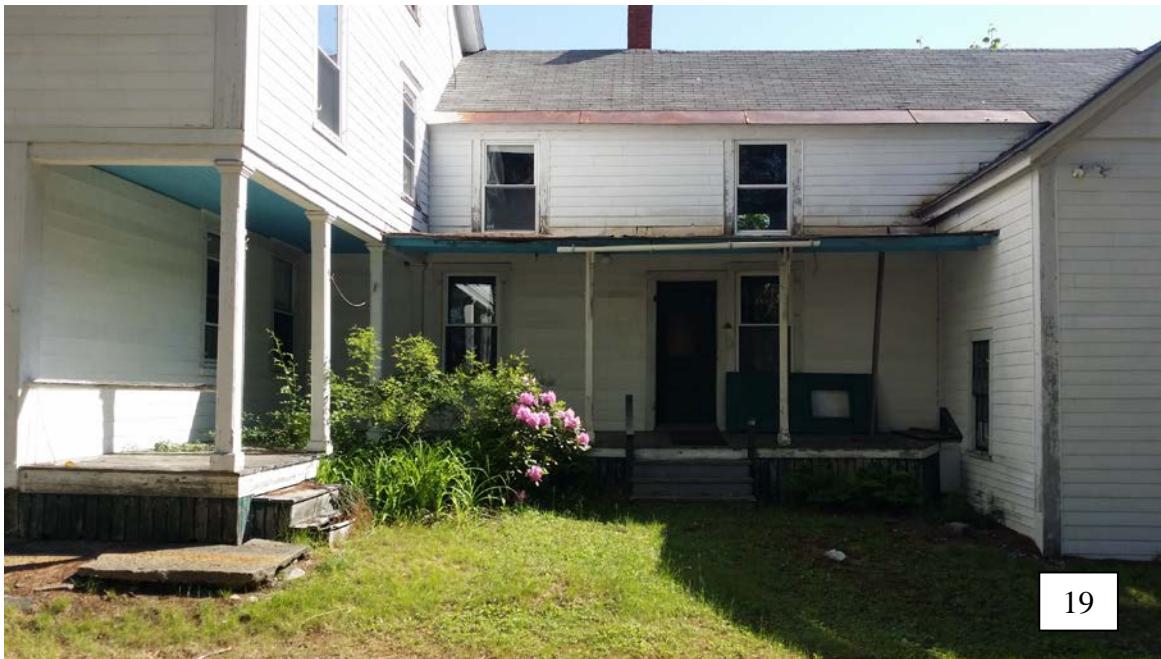
19

The north side porch floor has a noticeable pitch downward to the north, though some of this may be attributed to design and some to the simple foundation. As mentioned, the street entry area has some deteriorated wood, but the remainder is serviceable and largely in original condition. The insect screening is well preserved. The roll roofing on the low-pitched roof has failed.

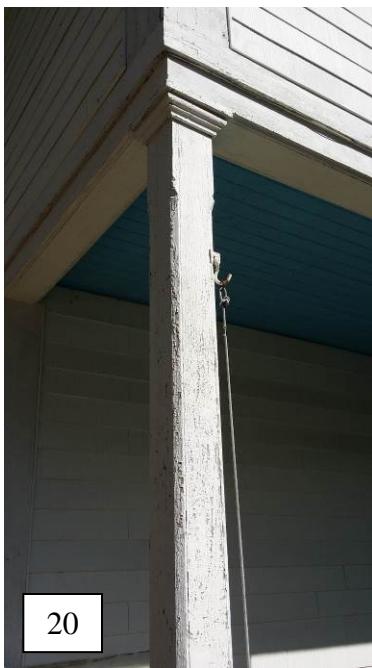
20

The south side porch requires maintenance and repair. We know the westerly portion of this “L” shaped porch was created when the rooms above were extended around 1900. It appears that when built it had a colonnade of three equal bays facing east. The inadequate design of the footings (supporting brick piers under these built-up columns) has allowed this roughly six-foot extension of the house to subside a few inches. This can be seen on this level and above. It is clear that the original foundation wall running north-south is sound—it aligns with the highpoint of the floors. Between the sinking toward the center of the house and the subsidence of the porch, there is a slight north-south ridge running through the structure.

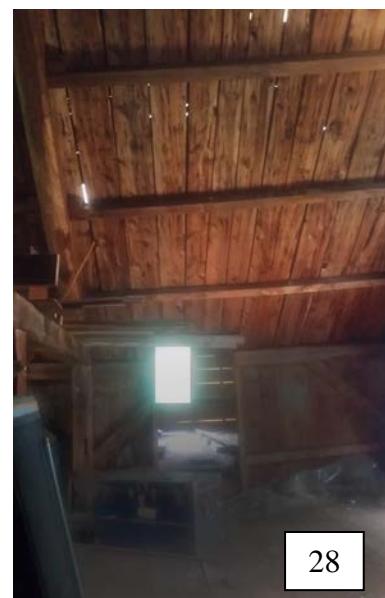
28

Moving up to the barn loft we can see where the construction of the horse stall addition has caused some problems in the older barn. The roof of the addition was built over the existing barn, supported on the old barn roof and subjecting it to some additional roof loading. In addition, the barn frame has been modified in this area by the removal of some knee braces that were inconveniently low (mortises indicate their former position). The resulting roof deflection is visible in the photo (28) at right.

2. Stabilize the barn. As Team Engineering reports, the barn has the greatest deficiencies and is likely to be damaged first by winter snow loading. Their report identifies two basic problems: inadequate foundation support and undersized roof framing—the latter exacerbated by the fact that the loft is partially hung from the roof. Securing separated connections in the barn and restoring removed framing members is straightforward. The future use of the barn (which is an important piece of historic fabric of the site) is so far undetermined. Access to this area should be restricted until repairs are undertaken.

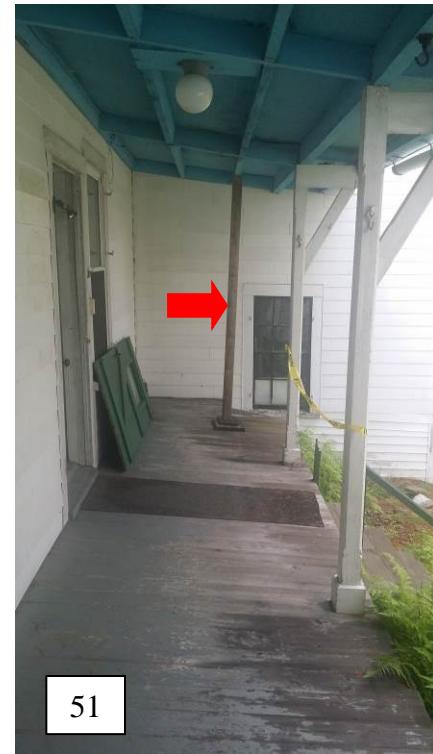
As mentioned, the south porch has subsided, taking the floor above with it and so requires shoring up and a rebuild of the simple footings. The low-pitch porch roofing outside of the kitchen has failed from age, and the more modern framing has also given way. Railings that used to flank the steps are largely gone. Note the shoring post at center of the photo at right.

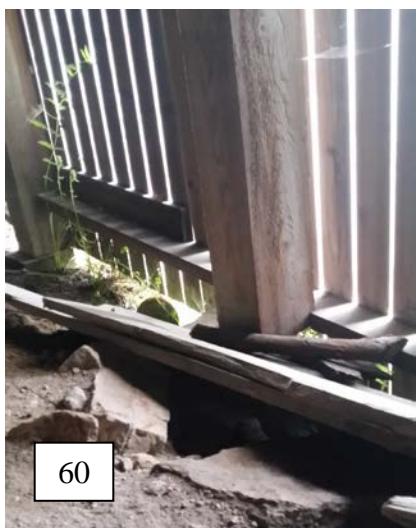
60

The north side porch has moved due to inadequate support, though not as dramatically as on the south side (note leaning lattice work at right). The roll roofing has failed on the low-pitched roof as well. However, it is a simple construction and appears to be relatively easy to repair.

1. Fix the roof. Re-shingling in-kind with asphalt shingles (30-year, 3-tab) over a complete layer of new ice and water shield would go the furthest to protecting the house. Low-pitched roofs over the two porches would benefit from modern membrane roofing, fully adhered. However, it is not recommended to re-roof the two areas until the underlying problems are solved: the poor framing of the south porch roof and the apparent displacement of the superimposed barn roof where the horse barn was added. Care should be taken to remove and replace the glass and metal lightning rods.

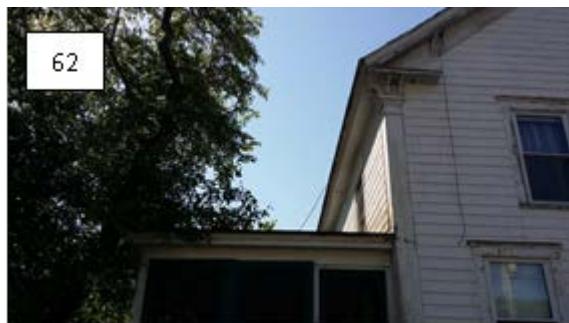
62

The house roof above has lost nearly all of its shingles. Decorative brackets, trim and other roof details appear to be intact and are significant contributors to the character of the building.

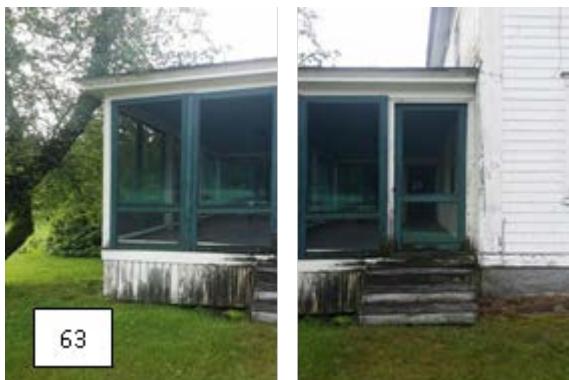
63

The NW corner at the front of the house is exposed to the most extreme weather, and the fact that the flat porch roof and the house roof above also drain to this point has combined to make this a damp area. The problem appears to be localized. The cause is curable, and restoration-in-kind would not be burdensome.

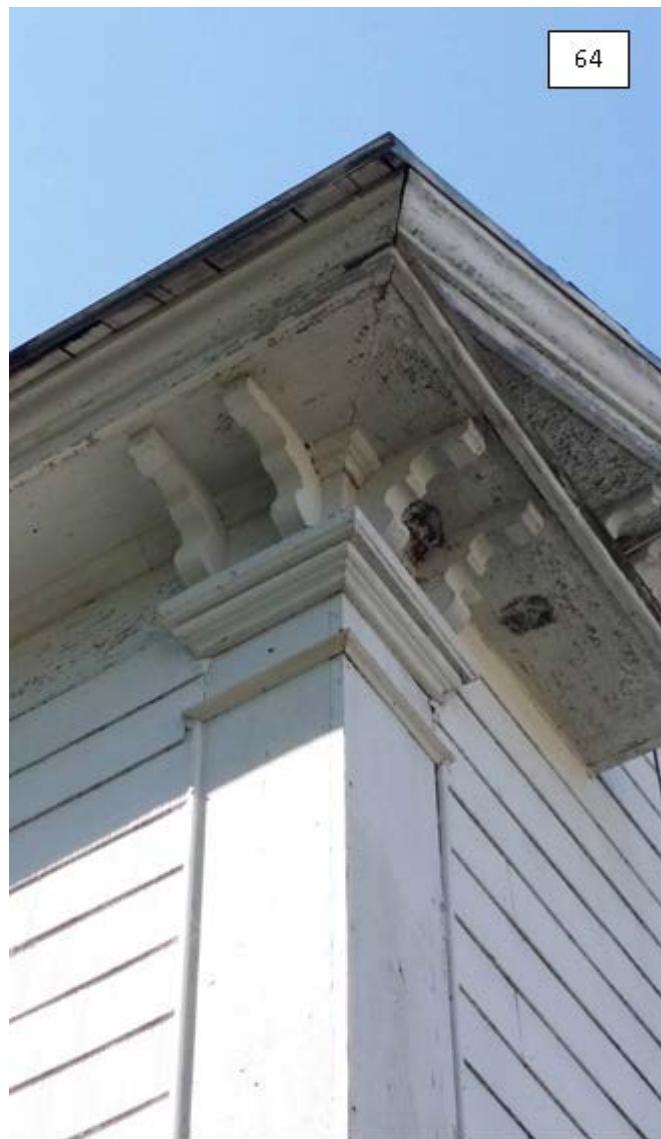
64

At the roof elevation, much of the weathering is minor and recoverable with reasonably standard maintenance. The photo at right shows that much of the character-defining architectural detail is well preserved.
