LAKE KANASATKA

WATERSHED-BASED MANAGEMENT PLAN

PREPARED BY FB ENVIRONMENTAL ASSOCIATES
in cooperation with the Lake Kanasatka Watershed Association

August 2022 | **FINAL**

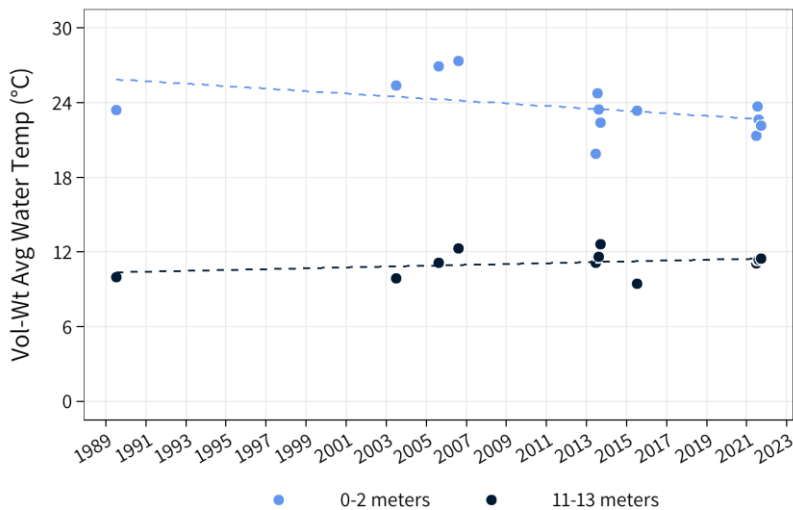
Figure 11. Volume-weighted average water temperatures for 0-2 meters and 11-13 meters in Lake Kanasatka from 1989-2021 for June-September. Calculated using R package *rLakeAnalyzer*.

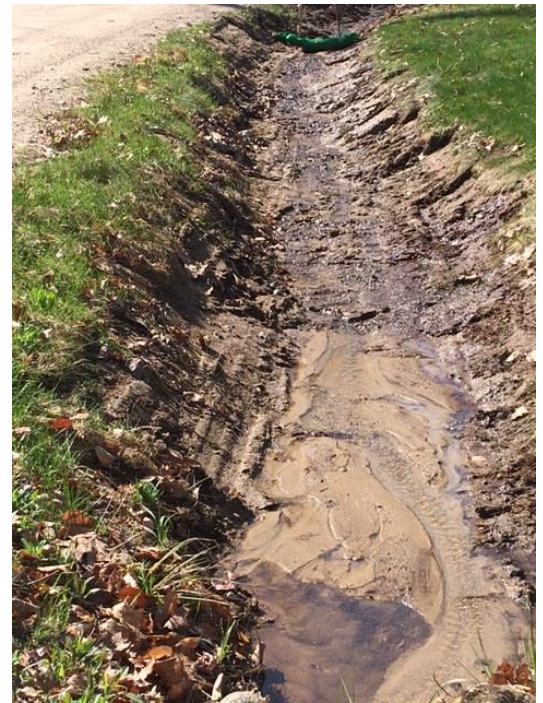
Road ditch maintenance causing erosion on Avon Shores Rd, May 2022. Photo credit: Kevin Kelly.

Recommendations: It is recommended that an inspector is sent to review the erosion and sediment controls and that additional erosion controls (e.g., silt fence, erosion control mulch) be explored and/or added in an organized and effective manner.

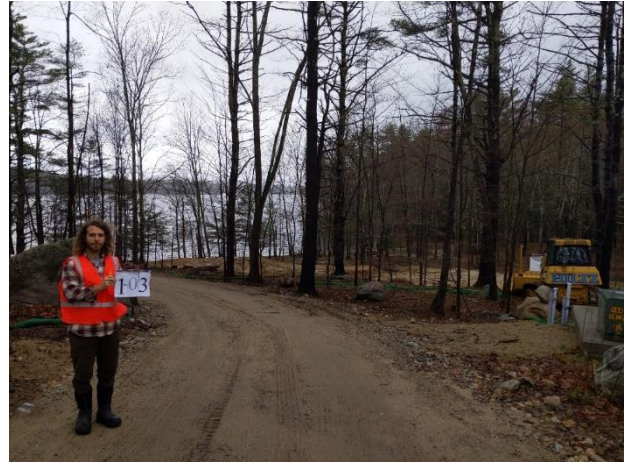
View of construction site from the top of Shady Lane.

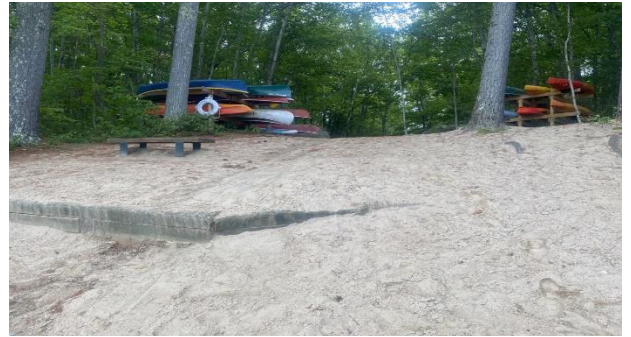
Steep grade leading from parking area directly to pond, showing overtopped, wooden retaining wall.

Recommendations: Work with the right of way stakeholders to determine the needs and use of this common area. Any sand replenishment should be stopped. A defined access area should be established. We recommend installing infiltration steps from the parking area down to the water. Mulching and planting all other areas would also decrease erosion and runoff.

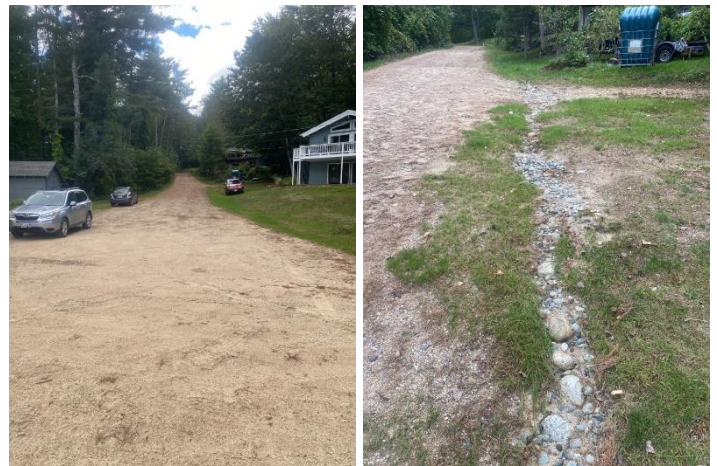
(Left) Steep grade leading directly to beach area/lake, (Right) eroded left side of road running off into gully.

Recommendations: Consider halting any beach sand replenishment and leaf raking. The addition of a retaining wall with sediment forebay to define parking the parking/beach boundary would also collect any surface material runoff. Regrade the road to further divert water into the woods on the right side of the road (if facing the lake). Assess the condition of the flow channel through the woods for any further modification or water treatment and stabilize the underground pipe outlet with possible rock-lined plunge pool.

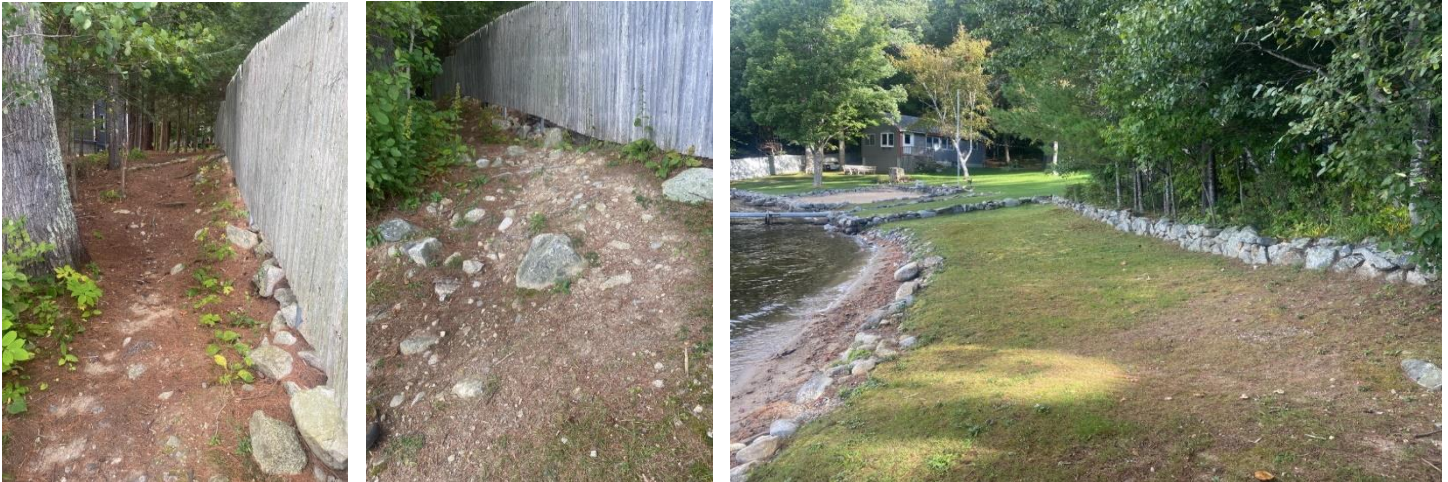
(Left) Erosion along path leading down to water, (Middle) steep area at end of path, and (Right) grass sitting/common area.

Recommendations: Add multiple water bars with infiltration trenches. It would also be beneficial to add erosion control mulch to the path and infiltration steps to the end of the trail, where the path steepens before reaching the water. Plant shade and acidic soil loving shrubs along the access way to manage erosion at this site.

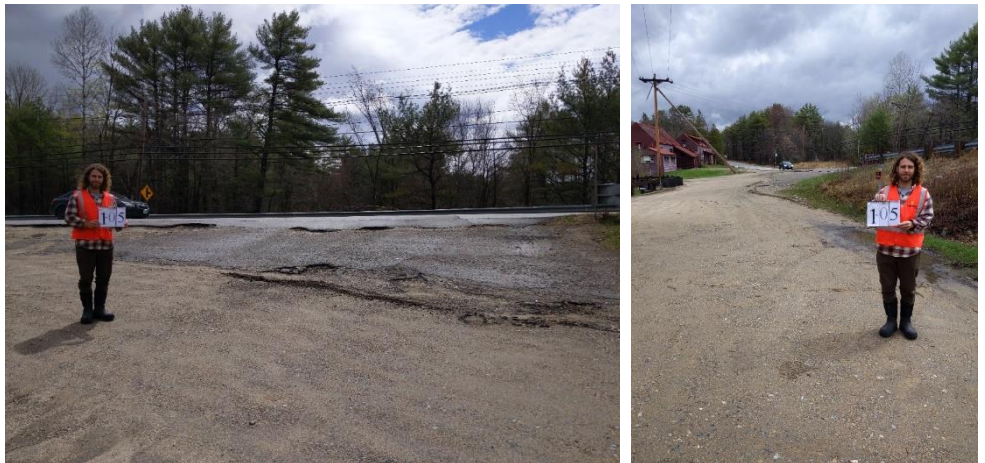
(Left) The edge of Route 25 where vehicles enter the parking lot. (Right) The dirt parking surface.

Recommendations: Regrade and pave the entry to the parking lot and consider either paving or adding permeable pavers on the dirt parking lot surface. Pave or install permeable pavers on the boat launch. Add a vegetated buffer around the dam. This is a great spot to install signage or other educational material about water quality and erosion on the existing kiosk.

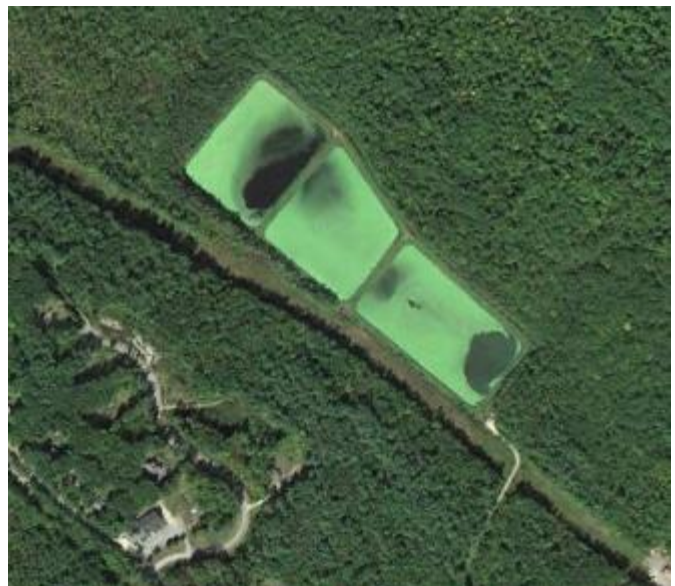
The series of three lagoons were built for wastewater storage (31-million-gallon capacity, 6 ft depth maximum) and secondary facultative treatment of wastewater prior to discharge to Lake Winnepesaukee. Solids settle to the bottom of the lagoons as sludge before liquid waste is discharged from the system. In 1990, the sewage lagoons’ discharge was diverted from Lake Winnepesaukee to a series of pumps and underground piping running along Route 25 from Moultonborough and Meredith to the centralized treatment plant in Franklin (owned and operated by NHDES). The lagoons currently serve 90 residential homes and 30 commercial properties, which contribute 58,000 gallons per day in winter and 104,000 gallons per day in summer (maximum allowance is 240,000 gallons per day). Four miles of collection lines and two pump stations move sewerage to the lagoons.

Aerial image of sewage lagoons in Moultonborough.

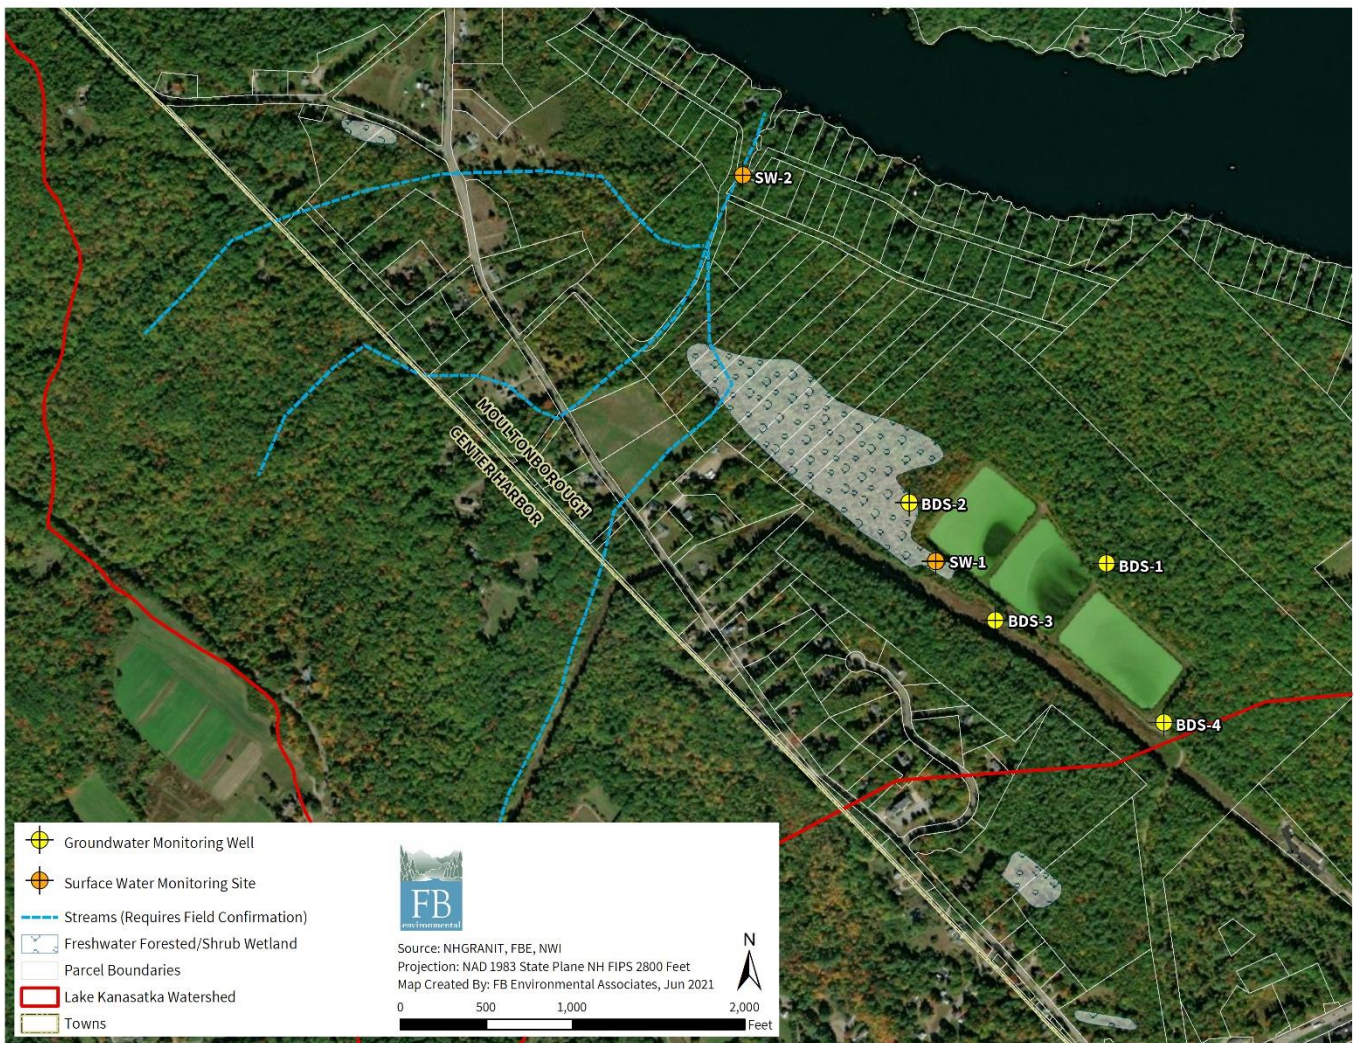
Figure 18. Monitoring well and surface water sample locations around the lagoons in relation to wetlands, draft stream channels, parcel boundaries, and Lake Kanasatka.

The lagoons operate under NHDES Groundwater Discharge Permit Number GWP-199007028-M-005 (expires 5/16/27) because the lagoons are currently considered unlined⁸ and potentially discharging to groundwater via infiltration. The original intent of the construction plans noted the use of a 2-4 ft deep compacted impervious fill around the lagoons, but the Bay District Sewer Commission was unable to provide adequate proof to NHDES who then classified the lagoons as unlined. Four groundwater monitoring test wells were installed around the lagoons in 2001 (Figure 18). The permit requires semi-annual testing of the wells for contaminants of interest, including chloride, total dissolved phosphorus, nitrate, pH, Total Kjeldahl Nitrogen (TKN), *E. coli*, specific conductance, volatile organics, per- and polyfluoroalkyl substances (PFAS), dioxane, arsenic, barium, boron, cadmium, chromium, lead, mercury, selenium, silver, temperature, and static water level. BDS-1 was installed upgradient of the lagoons to the east; three other downgradient wells were installed to the south (BDS-4), west (BDS-3), and north (BDS-2). Wells were installed 15-26 feet below ground. Two surface water sampling locations are being established under the newly issued 2022 permit: SW-1 is located immediately southwest of the northernmost lagoon in a small seep that discharges to the northwest into a large wetland complex; SW-2 is located in the stream where it crosses Kanasatka Rd.

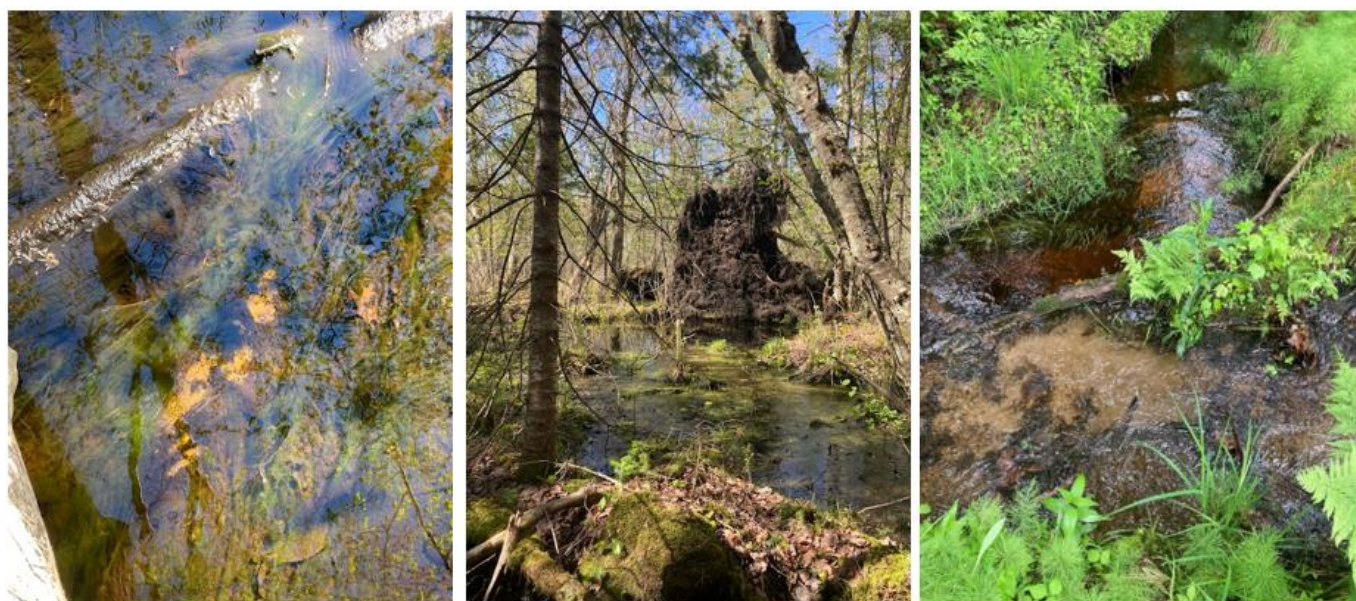
Excessive algae growth was documented by local volunteers in the wetland area draining from the lagoons (left, middle). Confluence point of Scribner Brook (flowing in from right) and Bay District stream (flowing in from above) (Location 1) on 5/31/2021, after 1.5 days / 0.9 inches of steady light rainfall (right). Photo Credit: Woody Cartwright.

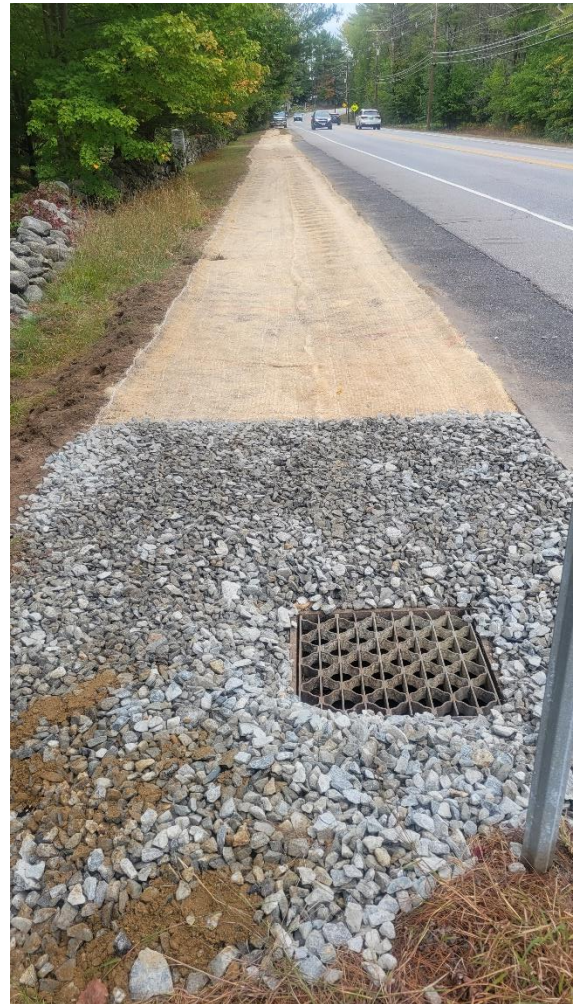
Improved road ditch maintenance along Route 25 in Moultonborough. Photo credit: Kevin Kelly.
