LAKE KANASATKA

WATERSHED-BASED MANAGEMENT PLAN

PREPARED BY FB ENVIRONMENTAL ASSOCIATES
in cooperation with the Lake Kanasatka Watershed Association

August 2022 | **FINAL**

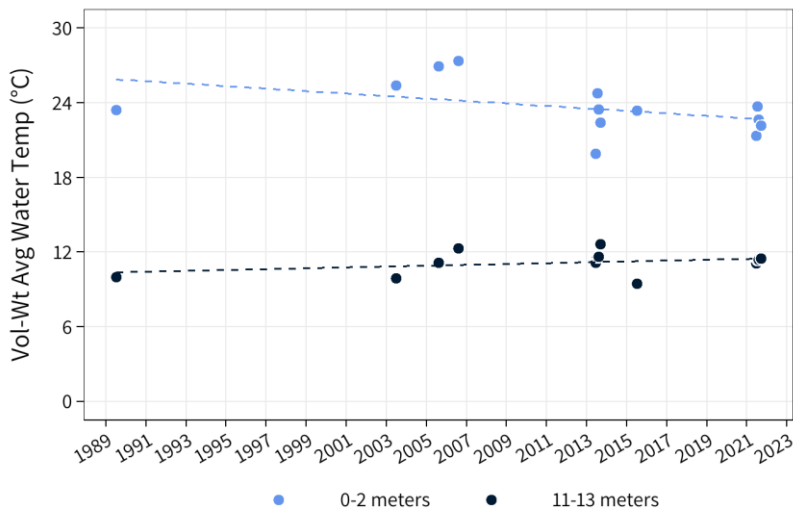
Figure 11. Volume-weighted average water temperatures for 0-2 meters and 11-13 meters in Lake Kanasatka from 1989-2021 for June-September. Calculated using R package *rLakeAnalyzer*.

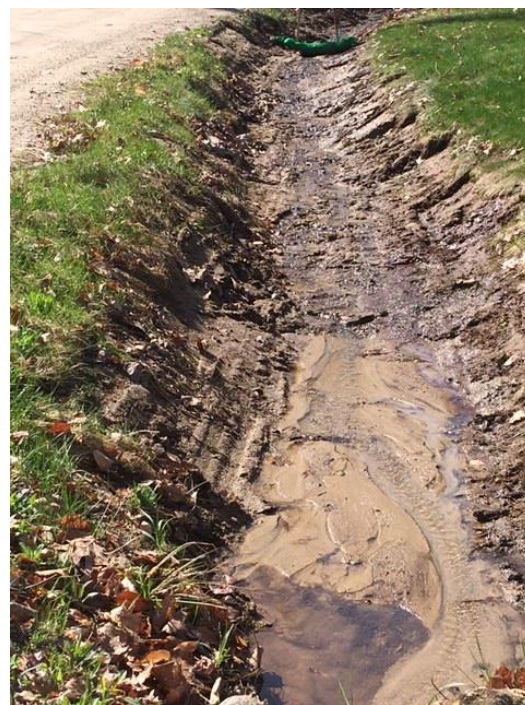
Road ditch maintenance causing erosion on Avon Shores Rd, May 2022. Photo credit: Kevin Kelly.

Recommendations: It is recommended that an inspector is sent to review the erosion and sediment controls and that additional erosion controls (e.g., silt fence, erosion control mulch) be explored and/or added in an organized and effective manner.

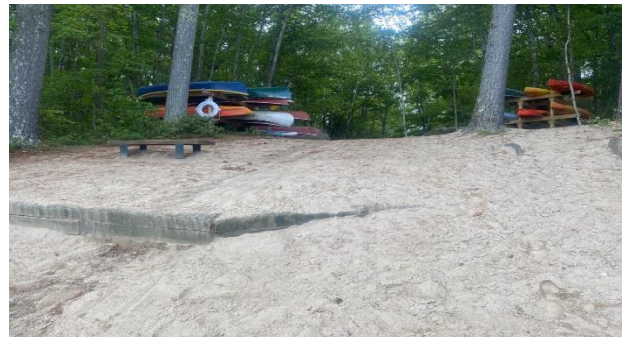
Steep grade leading from parking area directly to pond, showing overtopped, wooden retaining wall.

Recommendations: Consider halting any beach sand replenishment and leaf raking. The addition of a retaining wall with sediment forebay to define parking the parking/beach boundary would also collect any surface material runoff. Regrade the road to further divert water into the woods on the right side of the road (if facing the lake). Assess the condition of the flow channel through the woods for any further modification or water treatment and stabilize the underground pipe outlet with possible rock-lined plunge pool.

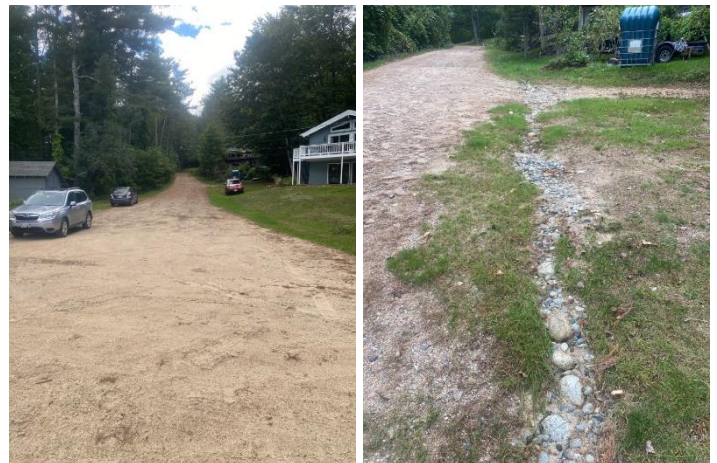
(Left) Steep grade leading directly to beach area/lake, (Right) eroded left side of road running off into gully.

Recommendations: Add multiple water bars with infiltration trenches. It would also be beneficial to add erosion control mulch to the path and infiltration steps to the end of the trail, where the path steepens before reaching the water. Plant shade and acidic soil loving shrubs along the access way to manage erosion at this site.

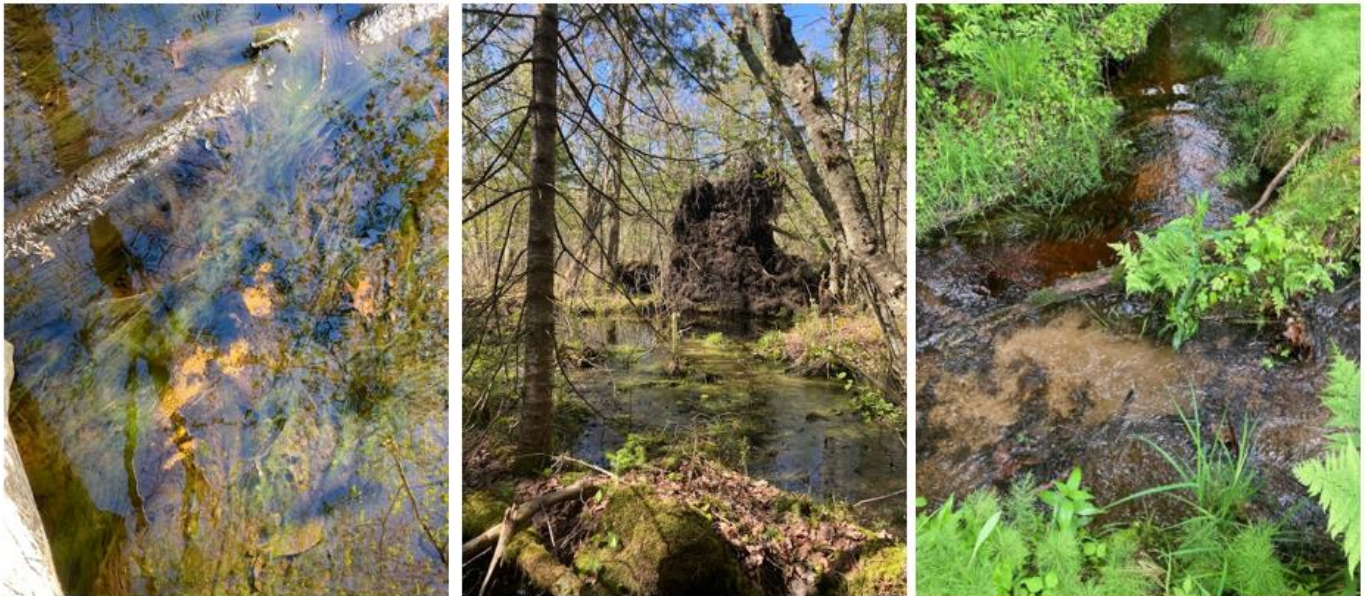
Excessive algae growth was documented by local volunteers in the wetland area draining from the lagoons (left, middle). Confluence point of Scribner Brook (flowing in from right) and Bay District stream (flowing in from above) (Location 1) on 5/31/2021, after 1.5 days / 0.9 inches of steady light rainfall (right). Photo Credit: Woody Cartwright.
