September 7, 2017

Property: Taylor-French House  
970 Whittier Highway  
Moultonborough, NH 03254

At your request, an engineering consultation regarding the above property was performed on August 3, 2017. The primary purpose of the inspection and this report is to assess the general condition of the existing structure of the Taylor-French House.

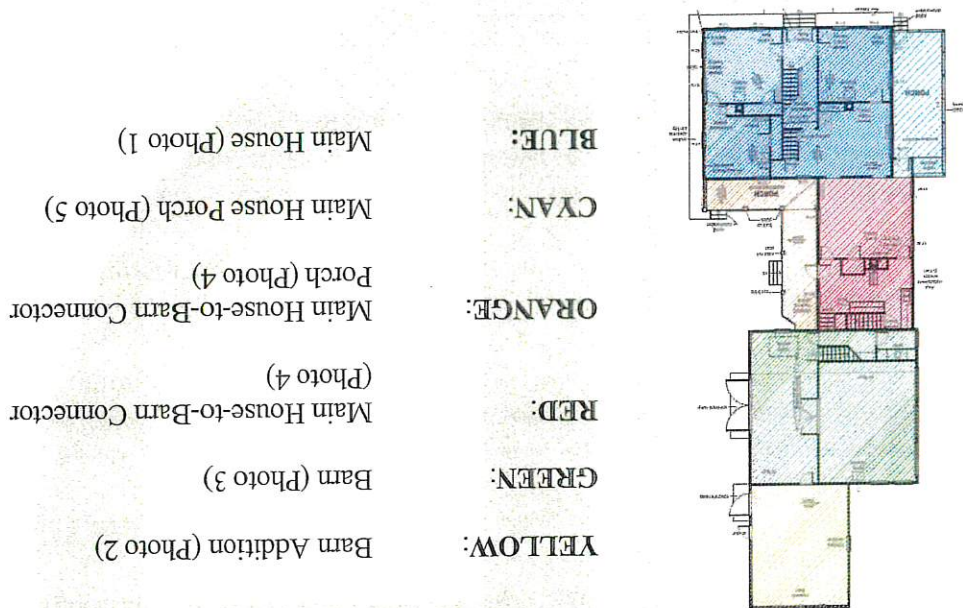
**FIGURE 1. GENERAL BUILDING FOOTPRINT**

For ease of this report, we have separated the building into (6) distinct sections. The following figure represents the delineation for each section:

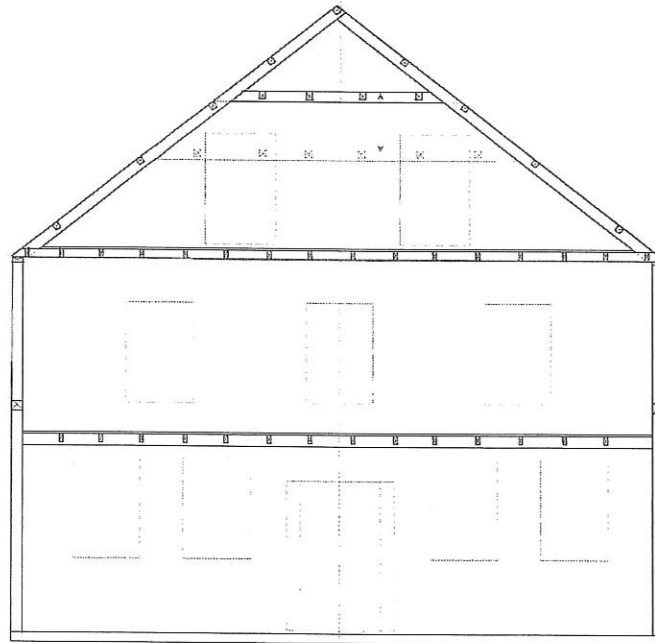
**FIGURE 2. EXISTING MAIN HOUSE ROOF FRAMING (by James Garvin)**

Two 2"x8" attic floor beams tie directly into the bottom of the roof rafters (Photo 8), which may have been originally intended to resist outward thrust. Additionally, the remaining 2"x8" attic floor joists were installed perpendicular (north-to-south) to these members and spaced 24" on-center as shown in Figure 2 above.

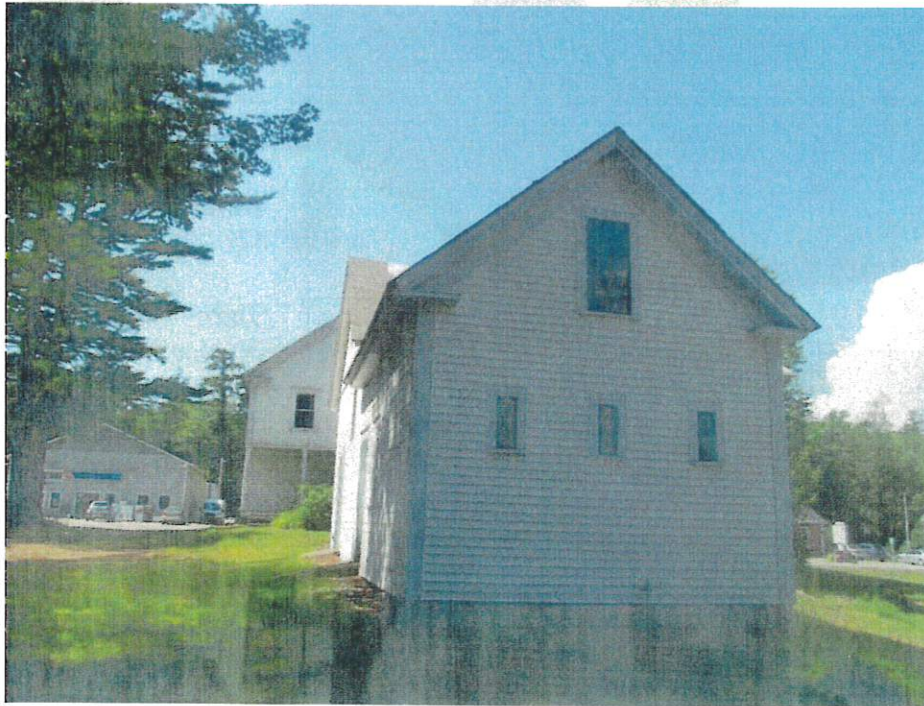
**Photo: 2**

**Description:**  
Barn Addition East  
Elevation

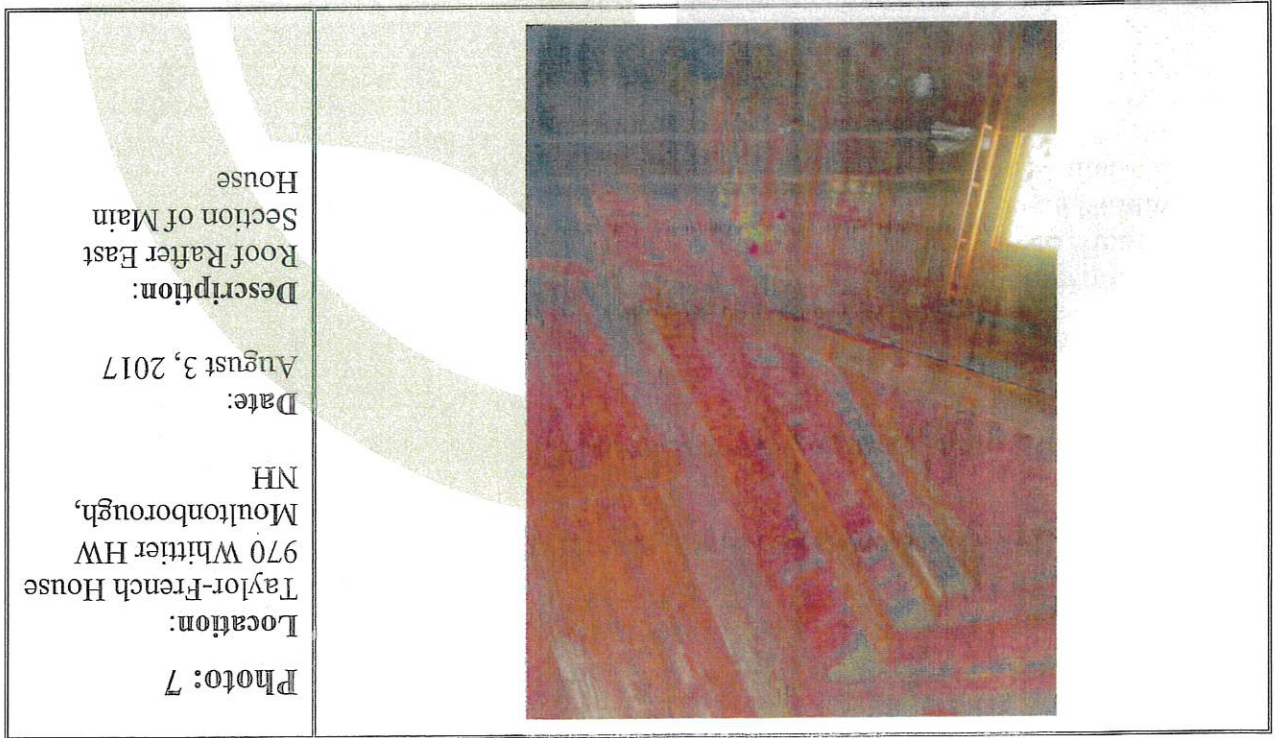
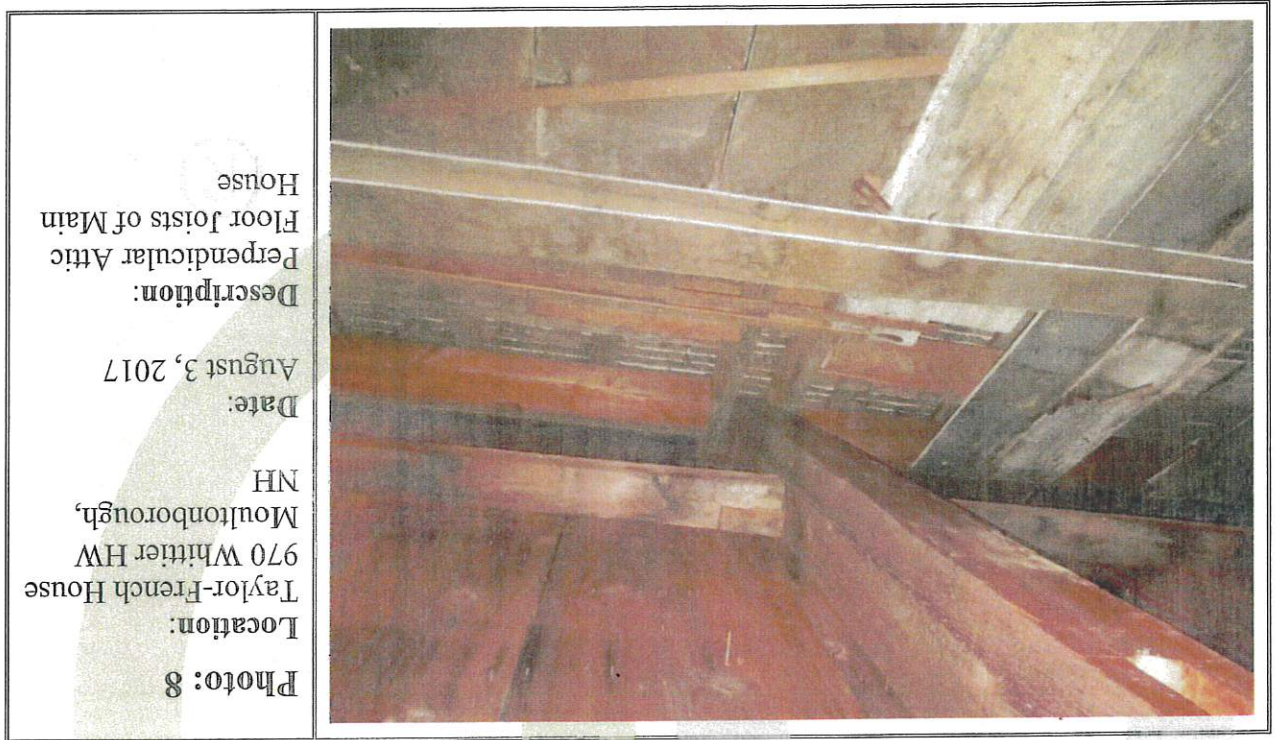
**Photo: 6**

It appears that the main house was originally constructed using a timber post and beam framing system (Photo 6). This was observed in the roof/attic framing where 6"x8" timber rafters are spaced approximately 8 feet on center. These rafters span approximately 12 feet horizontally in the east-to-west direction and are at an approximate 10V:12H pitch. There are 4"x4" purlins connected into the roof beams spaced approximately 3 feet on center horizontally spanning north-to-south. We observed collar ties (4"x5") at rafter locations just above mid-height of the gable triangle for the attic space.

**Description:**  
Post & Beam Roof  
Framing for Main  
House

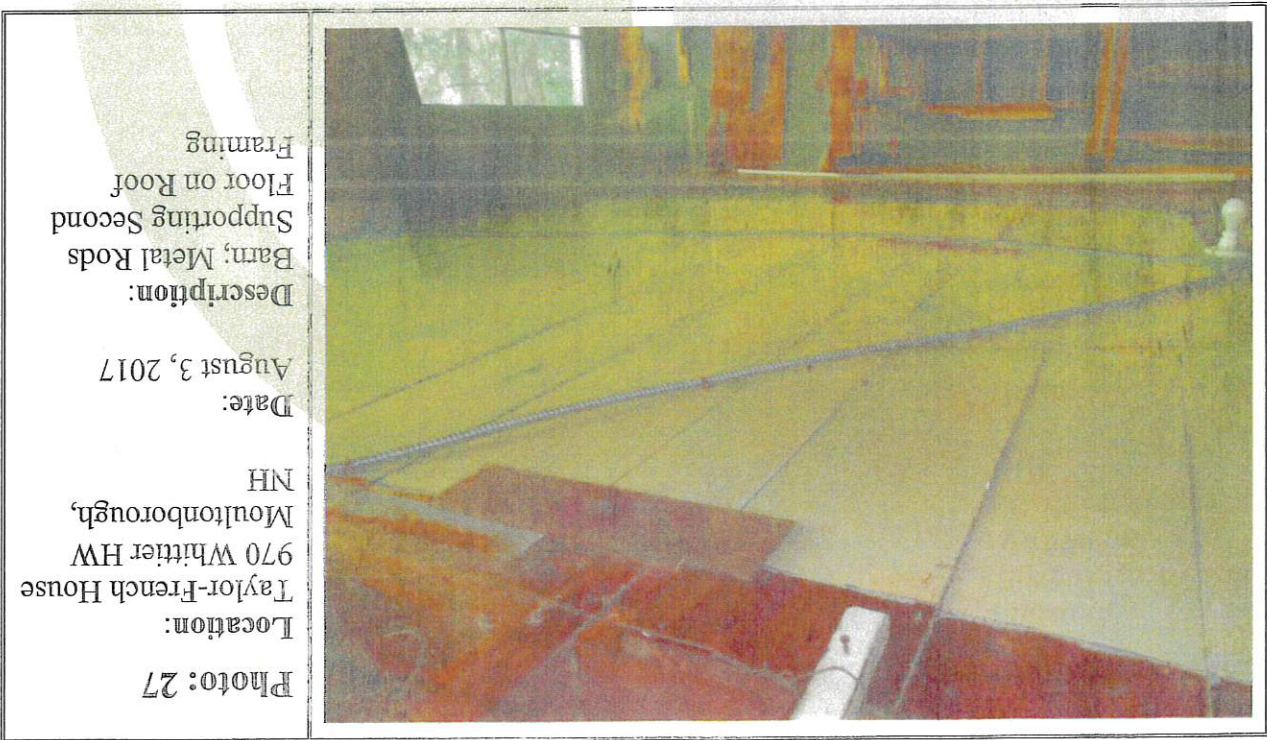
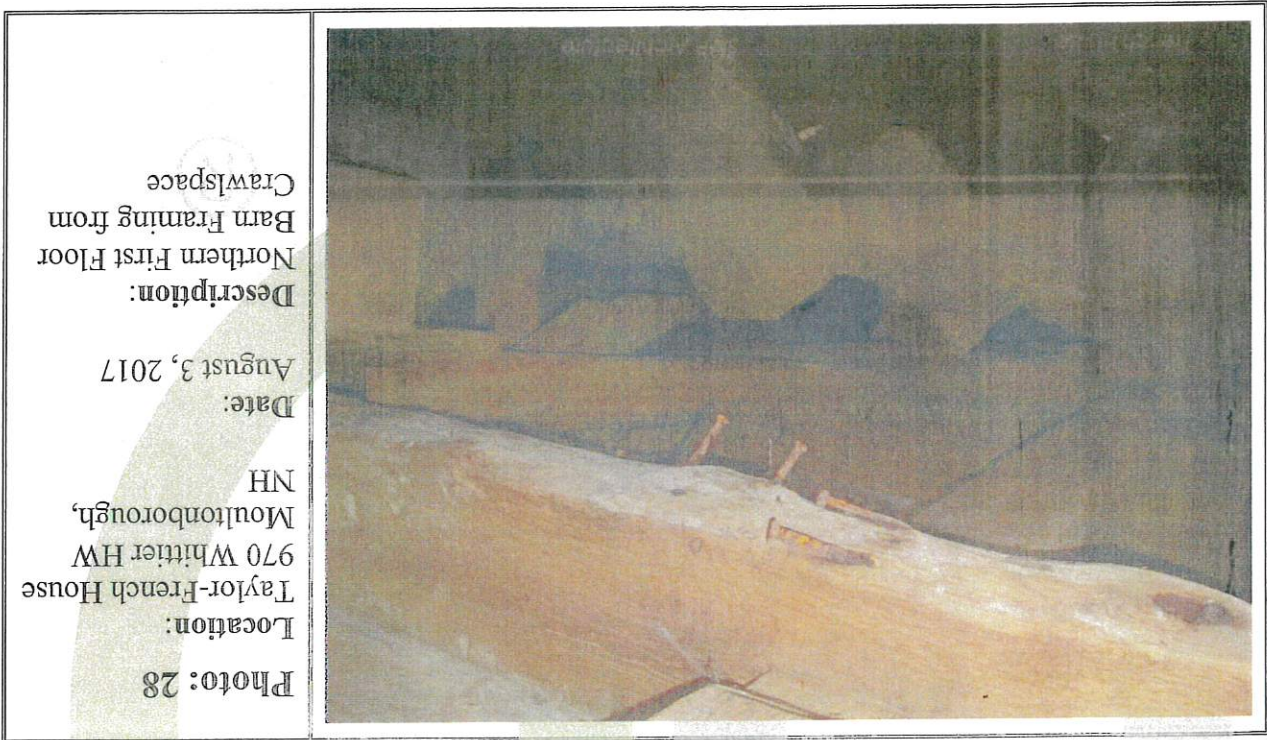
**Description:**  
Barn; Metal tension  
rods in second floor  
framing
