# The French-Taylor House

970 Whittier Highway,  
Moultonborough, New Hampshire

## Historic Building Condition Assessment

July 2017/ Revised February 2018

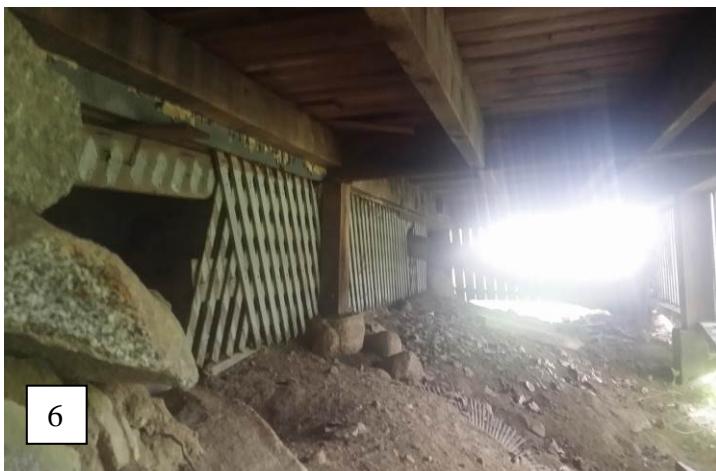
6

A salvaged door leads from this basement to the exterior under the north porch. A curving masonry passageway leads to the north side of the house. The raised platform on the north porch was apparently created to provide headroom here.

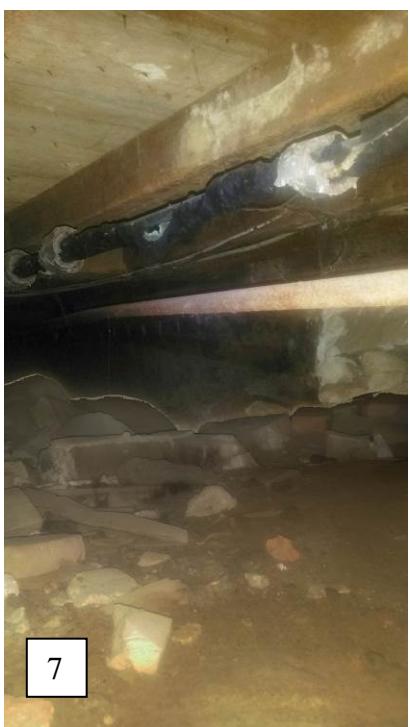
7

The crawlspace under the north porch reveals that the older porch (visible in period photographs) is still there. Mr. French's c.1900 porch is about twice the width, and simply covered over the old, concealing it with more solid latticework. Again, we see simple foundations consisting of medium-sized stones.

The space under the south porch is not accessible, but the brick piers are visible through the slats below the deck.

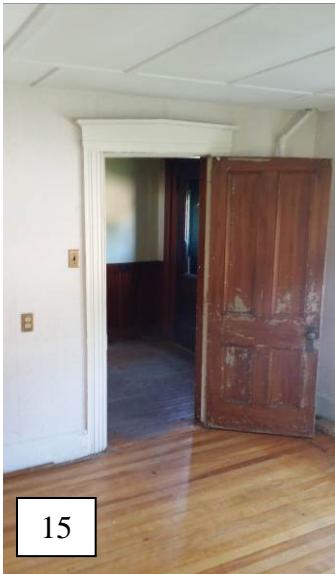
The principal ground-floor rooms of the main house are in good condition. The floors in these four rooms all slope slightly downward toward the center of the house (where we see the old reinforcing piers below). The floor surfaces are in good condition. Different species of wood were used from room to room as shown on the plan.

Much of the original c. 1840 interior trim remains, particularly the moldings and shallow pediments over the doors, though a bit racked by the subsiding floor. Three of the four rooms have had wallpaper applied, while the smaller southeast room has

beadboard wainscot and ceiling, as does the entry hall, all in good condition. There is evidence of minor water staining on the wall in the southwest corner of the southwest room, however this does not occur in the room above, suggesting that this is not an ongoing roof problem. Elsewhere on this floor, staining is likely the result of a leaking radiator.

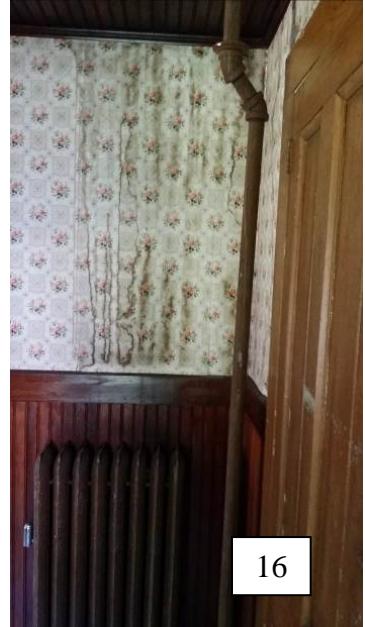
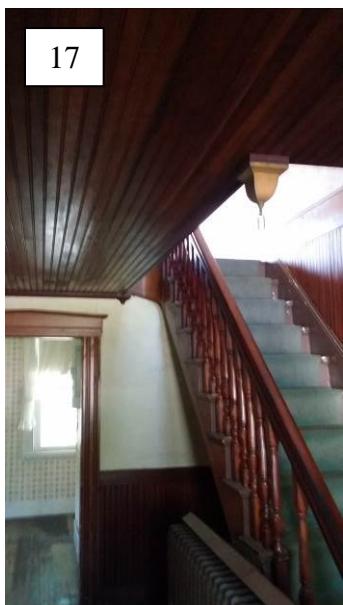
The NE, NW, and SW rooms all have beaverboard (wood fiberboard) ceilings with battens applied. Given what we know from the Garvin report, the absence of plaster ceilings in any room on this level may be a result of the process of raising the roof (and ceilings?) and inserting a new second floor.

The entry hall has sustained some recent damage to the stair balusters and the newel post, but missing pieces have been retained for repair and re-installation. This turned and carved wooden balustrade is a prominent feature of the entry.

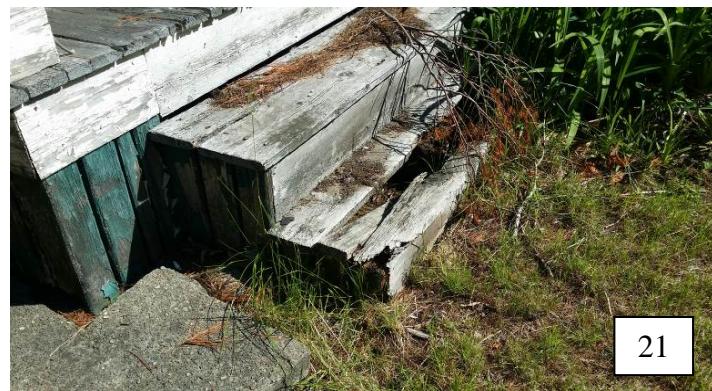
21

The wood columns themselves preserve some nice detail with chamfered corners and applied cornice. There is a bit of railing also surviving to the south. The three steps leading down to the door-yard have all but rotted away; the detailing and strange dimensions of these steps with very high risers may indicate that they were added as a D.I.Y. project at some point later in the house’s history, likely in the Taylor era.

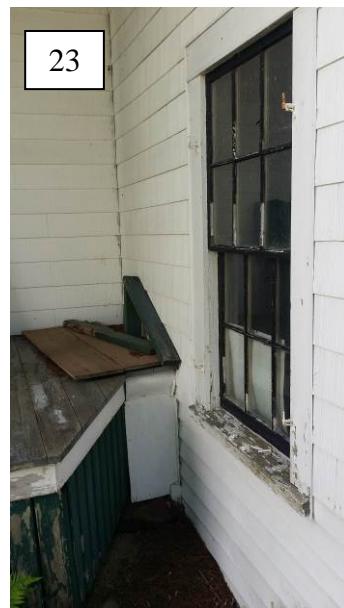
23

The northerly leg of the “L” is a little more mysterious. The two posts here are solid and detailed in a similar manner to the larger three to the west. There are also mortised brackets that are contemporary and in good shape. The roof deck here is later plywood, and it appears the roof framing is also more modern and has been extended to carry the roof farther out into the yard (this is visible where the last rafter meets the barn). The framing has failed and has been temporarily propped up with a timber near the kitchen door. The fact that the porch deck has to jog to avoid intersecting with the barn window to the east indicates that this part was modified from the original, and that the barn predates the porch. The trim at the edge of the floor deck in this narrow offset is also different from the adjoining. One hypothesis is that at one point the two solid posts held up a smaller roof that simply covered the steps up into the kitchen, and this was later tied in to the 3-bay porch. The strip flooring which runs lengthwise on both legs of the porch does meet in a mitered joint at the inside corner, which indicates that the two surfaces currently in place were likely put down together.

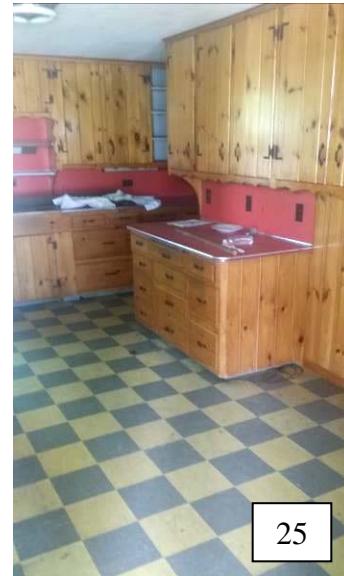
25

In the ell portion of the house, the westerly room most recently functioned as a dining room, adjacent to the kitchen to the east. It is over a crawlspace. This room has a taped drywall ceiling that has water damage in the NE corner. The trim in this part of the house is simpler than in the front original portion, but matches the floor above. A mechanical doorbell is mounted to the north porch door, indicating it was used as an entrance at some time.

Two doors connect to the kitchen in an arrangement that would have been more workable in the days of stand-alone stove, sink etc. More recent wood cabinets and counters line the north and west sides of the room. A small stove ties into the ell chimney. The checkerboard-patterned floor appears to be vinyl asbestos tile (VAT), albeit in good condition.

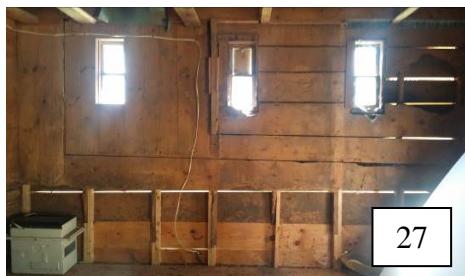
27

The south gable-end room of the barn has a fir floor that has swelled and buckled due to moisture. Double doors open out into the yard down a short concrete ramp, and another pair lead into the former workshop to the north. Overhead at the west end of the ante-room is a hatch for loading hay. A small gate opens to a stair leading up to the barn loft and on up to the rear bedrooms of the house, convenient before the installation of indoor plumbing.

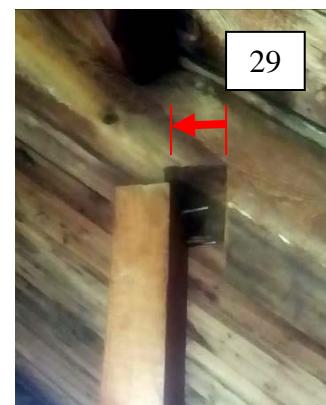
29

Also of note are the iron rods suspending the loft floor from framing above. They may have allowed the removal of some columns that would have interrupted the workshop space below. More evidence of the barn frame movement is seen where the NW post near the stair enclosure has pulled away from the roof beam above, perhaps as a result of the recent wind storm (March 2017). To the east is a single room one step up above the horse stall. The loft and roof are lightly built, with only 2x4 rafters and plywood sheathing.

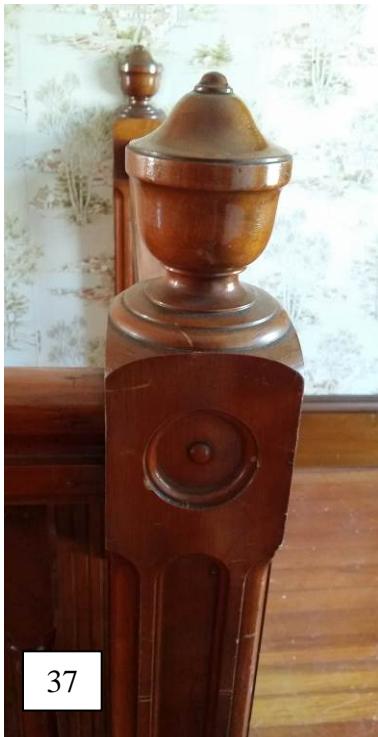
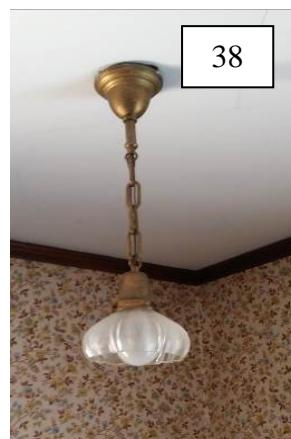
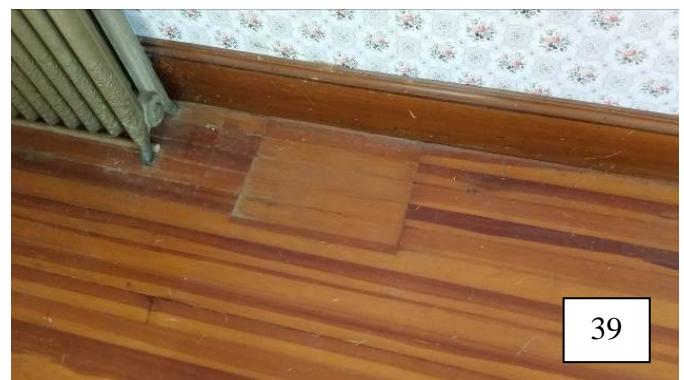
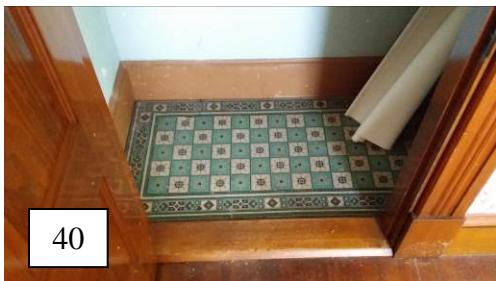
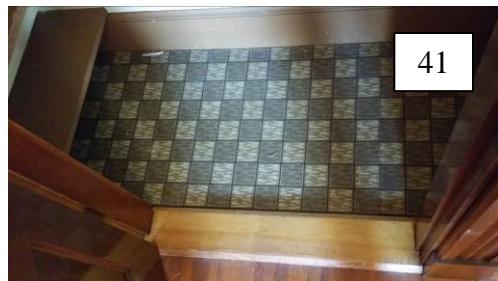
The four corner bedrooms are in relatively good shape, with important elements such as early lighting fixtures still in place. The floors show signs of having had linoleum or other area rugs in place for a long time, which protected the wood. In locations where floor registers were replaced with steam radiators, floor patches are visible. These floors likely date to the c.1900 insertion of the second floor.

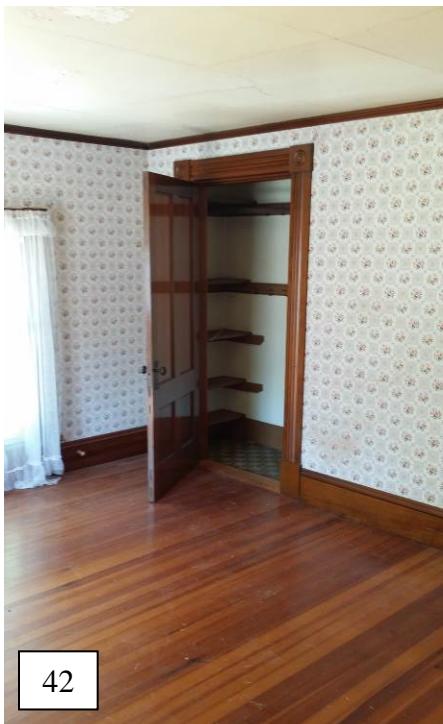
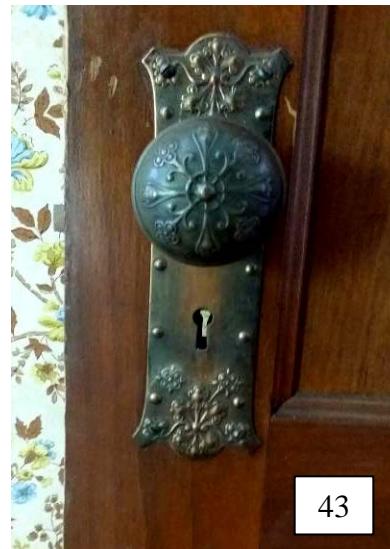
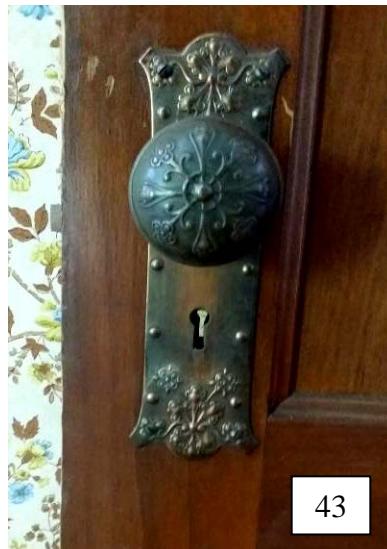
Most of the bedroom closets retain their linoleum rugs, some with borders designed to fit the space exactly. This is an important glimpse of the original c. 1900 condition, unchanged.

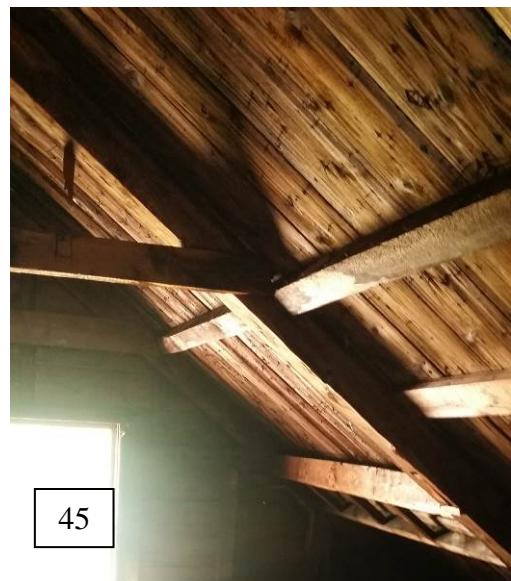
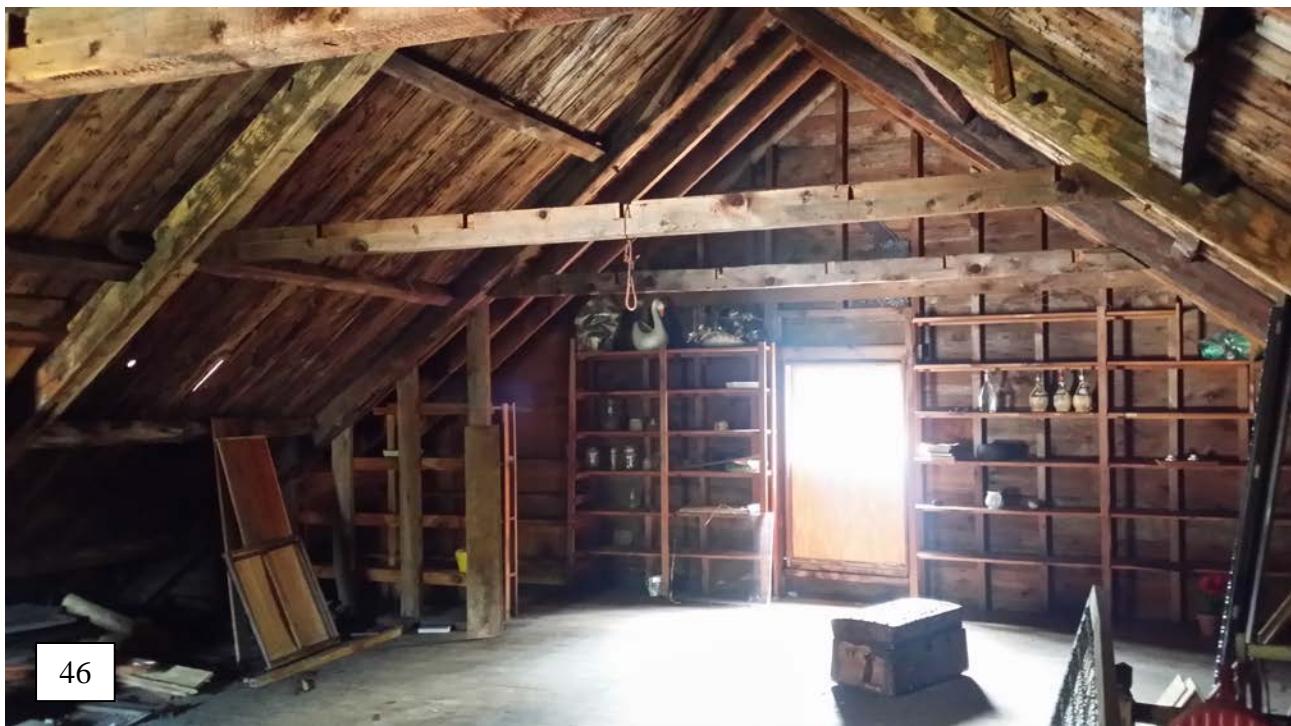
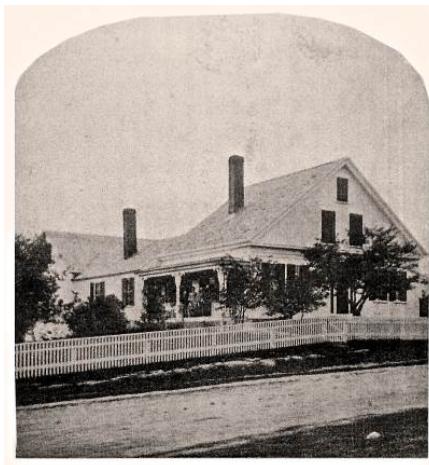
The east end of the main house attic clearly shows the roof extension toward the east. Roof framing for this last six feet goes from timber frames with vertical sheathing supported on hewn purlins to horizontal sheathing supported on sawn rafters that extend the full roof slope.

The roof structure has three evenly spaced collar ties (please refer to Garvin report). It appears to be in good condition, better than the barn, and not damaged from the wind storm. In some areas, the flooring appears to be put together from salvaged boards, and does not extend completely under the eave on the south side. The southerly of the two house chimneys terminates just below the roof sheathing. While the removal must have been done after the conversion to steam heat, the exact date is not known.

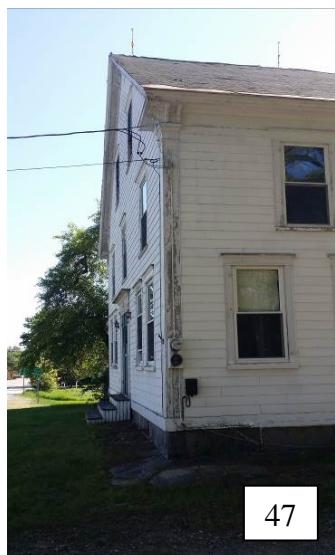
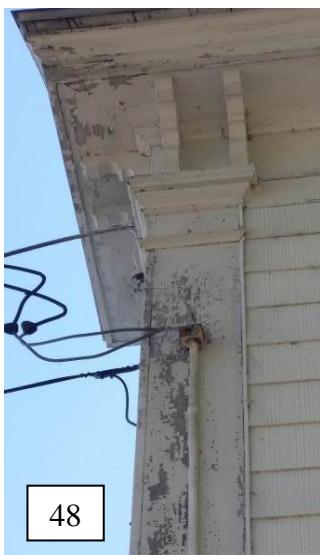
There is evidence in the wall framing, just below the peak on the west side, of the central window that appears in the stereograph taken prior to 1900.

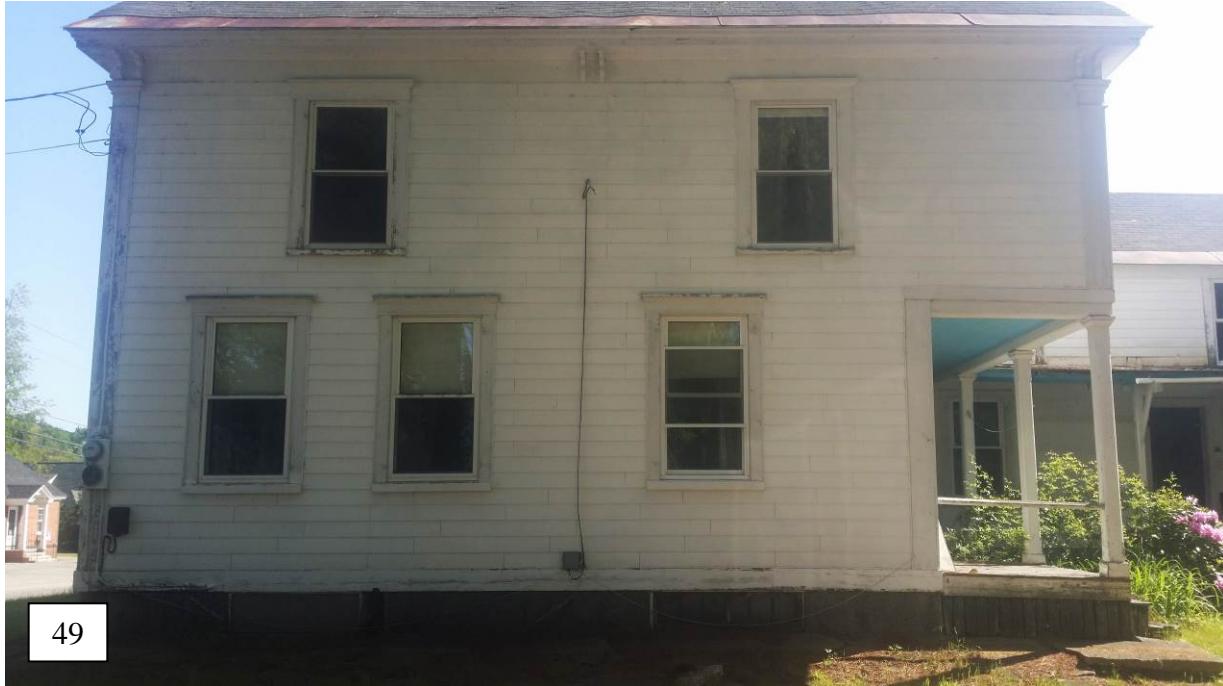
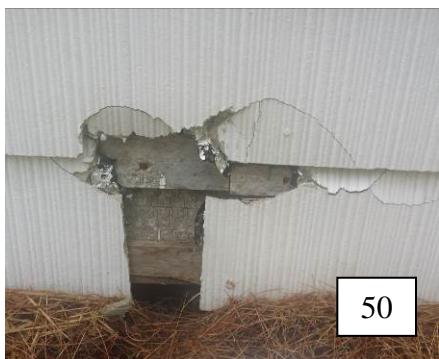
Beginning at the SW corner of the house: The south facing slope of the main house roof is shingled with three-tab asphalt and has a steel snow belt at the eave. The condition is poor. Decorative trim at the roof edge appears solid, but needs painting. Cornerboards have been retained in painted wood while siding has been covered with transite shingles.

At the overhead electrical entrance, the weatherhead is in need of upgrade (along with probable new electrical service).

1. Fix the roof. Re-shingling in-kind with asphalt shingles (30-year, 3-tab) over a complete layer of new ice and water shield would go the furthest to protecting the house. Low-pitched roofs over the two porches would benefit from modern membrane roofing, fully adhered. However, it is not recommended to re-roof the two areas until the underlying problems are solved: the poor framing of the south porch roof and the apparent displacement of the superimposed barn roof where the horse barn was added. Care should be taken to remove and replace the glass and metal lightning rods.

8. Remove and replace/restore clapboard siding.
9. Replace electrical service and branch wiring where substandard. Care will be needed to avoid damage to sensitive areas. Likely a 200 amp service would be sufficient, depending on intended use.

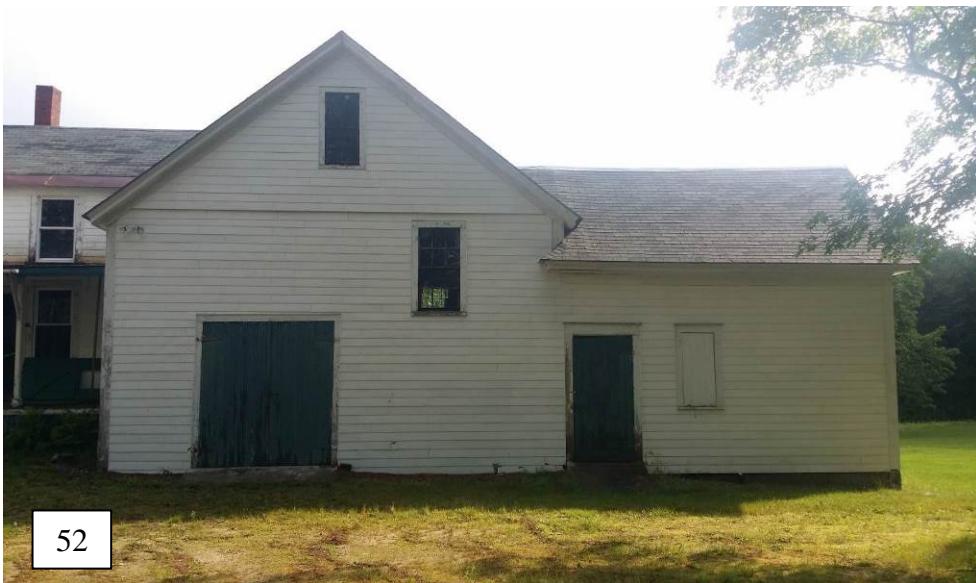
As mentioned, the south porch has subsided, taking the floor above with it and so requires shoring up and a rebuild of the simple footings. The low-pitch porch roofing outside of the kitchen has failed from age, and the more modern framing has also given way. Railings that used to flank the steps are largely gone. Note the shoring post at center of the photo at right.

The shingle roof above on the second floor is in better condition, *where remaining*. The accompanying plans give a letter grade to the roof conditions on various surfaces, but a piecemeal approach to replacement would not be economical in the longer run nor is it recommended. The kitchen chimney has open mortar joints visible from the ground—likely both chimneys need attention.

4. Repair chimneys. Loose brick need to be attended to before any brick loss. Pointing is a relatively minor bit of maintenance, though attention to the original mortar type and color is important. Temporarily capping the chimneys may also be a prudent step if a long period of vacancy is anticipated.

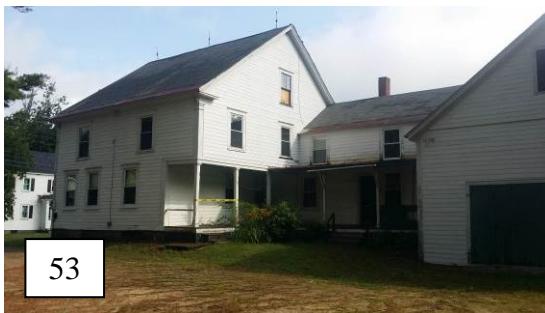
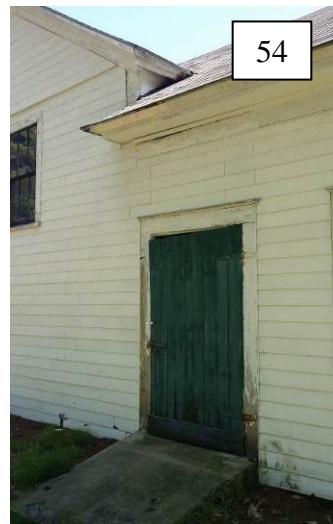
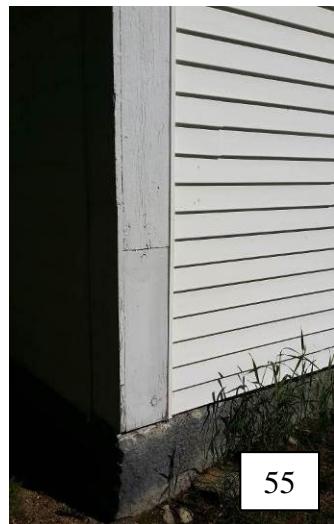
The barn roof is in marginally better condition than the adjacent house roof. Exterior trim and siding are in need of routine maintenance, but are not badly decayed. Recent spot repairs/replacement have occurred where painted wood is close to the soil. Original windows remain in the barn.

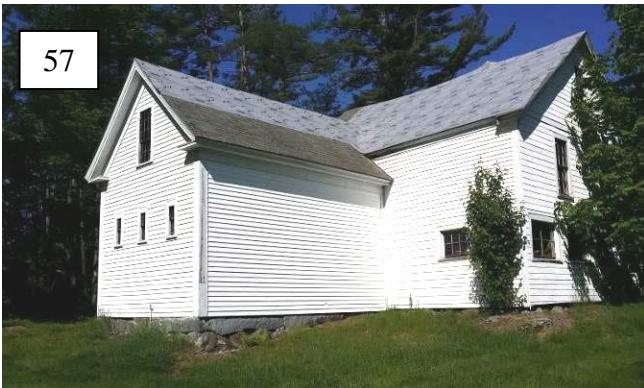
Along the east end of the barn and beyond (see plan), the transite shingles are replaced with more recent vinyl clapboards. The vinyl appears to be applied directly over the wood substrate—in fact in two locations it spans over former openings.

There is a capped stone (dug) well in the door yard approximately 24 feet south of the SE corner of the barn (refer to plan). It may be the source of domestic water; the modern well, if any, was not located.

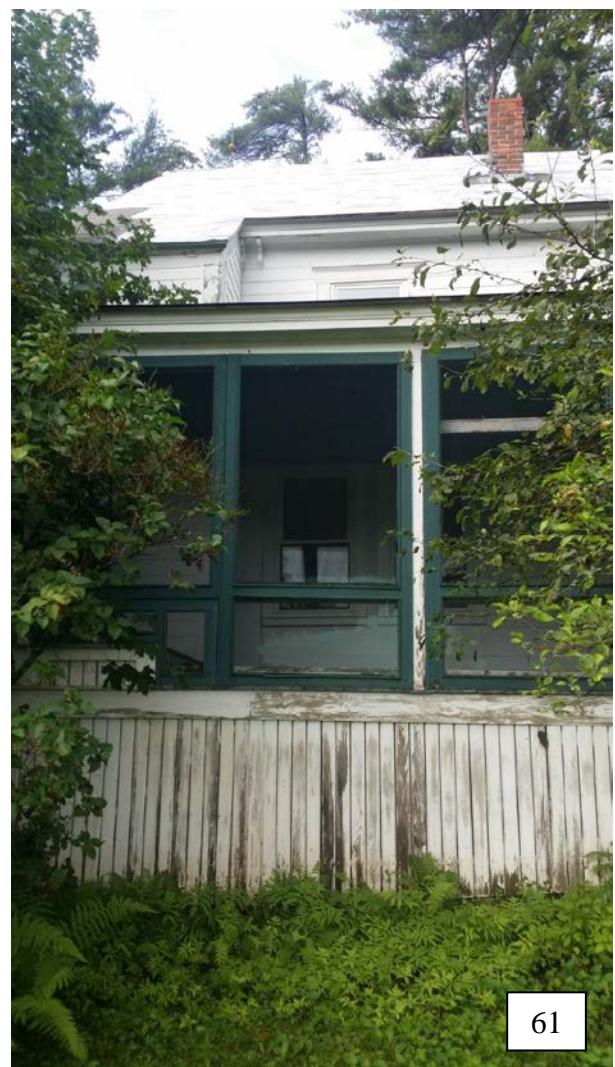
The basement entrance is behind the bushes. The crawlspace under the porch is not secured from unwanted visitors. If there was a door of some type at this location, it is gone.
