Prepared by:
NH Department of
Environmental Services
February 2021

Long-Term Variable Milfoil Management Plan

*Lake Winnipesaukee
Moultonborough, New Hampshire*

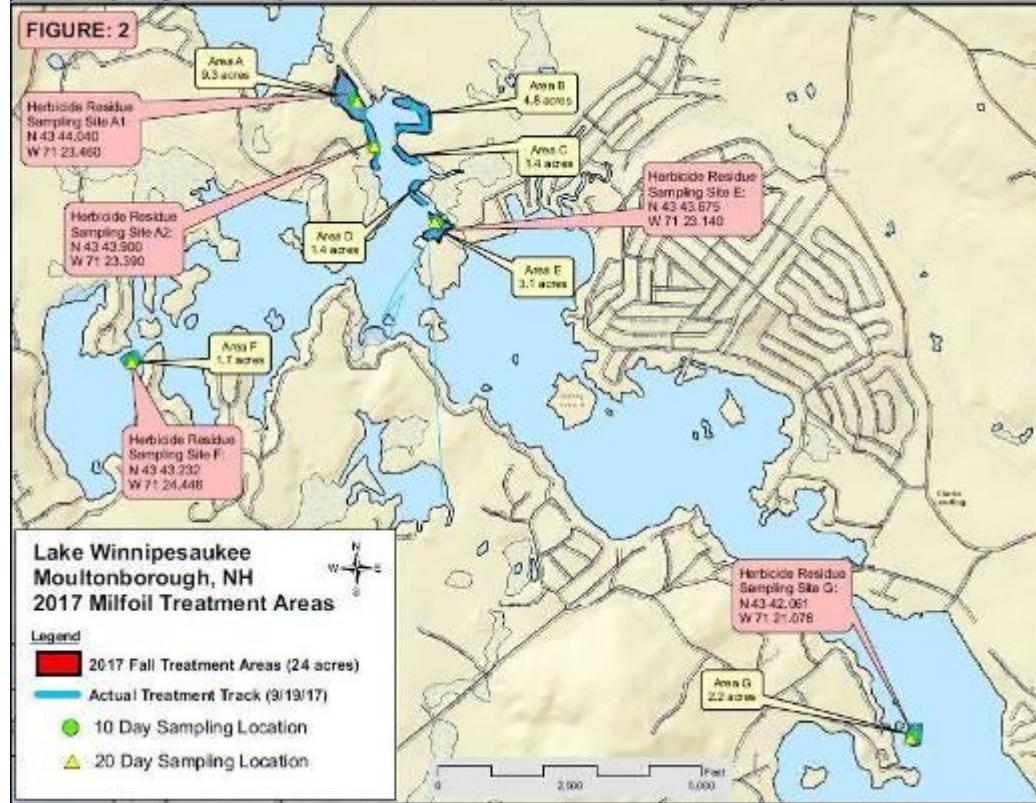
Figure 2: Variable Milfoil Control Actions

Figure 2 (a series of maps) show historic and proposed control activities for this area of Lake Winnipesaukee.

Year	Action	Responsible Party	Recommended Schedule
2024	Diving and DASH in areas recommended by DES based on field survey data	Contract Divers	June - October
	Herbicide treatment if/where needed (see maps in Figure 2 for specified growing season)	SOLitude Lake Management, LLC	Mid July
	End of season mapping/checks of management areas and planning for next growing season	NHDES/interested parties	September
	Field mapping of milfoil and planning for growing season control actions	NHDES	June/July/August
	Weed Watching and marking of areas of growth and Lake Hosting	Local Weed Watchers and Lake Hosts	Monthly from May through September
	Diving and DASH in areas recommended by DES based on field survey data	Contract Divers	June - October
2025	Herbicide treatment if/where needed (see maps in Figure 2 for specified growing season)	SOLitude Lake Management, LLC	Mid July
	End of season mapping/checks of management areas and planning for next growing season	NHDES/interested parties	September

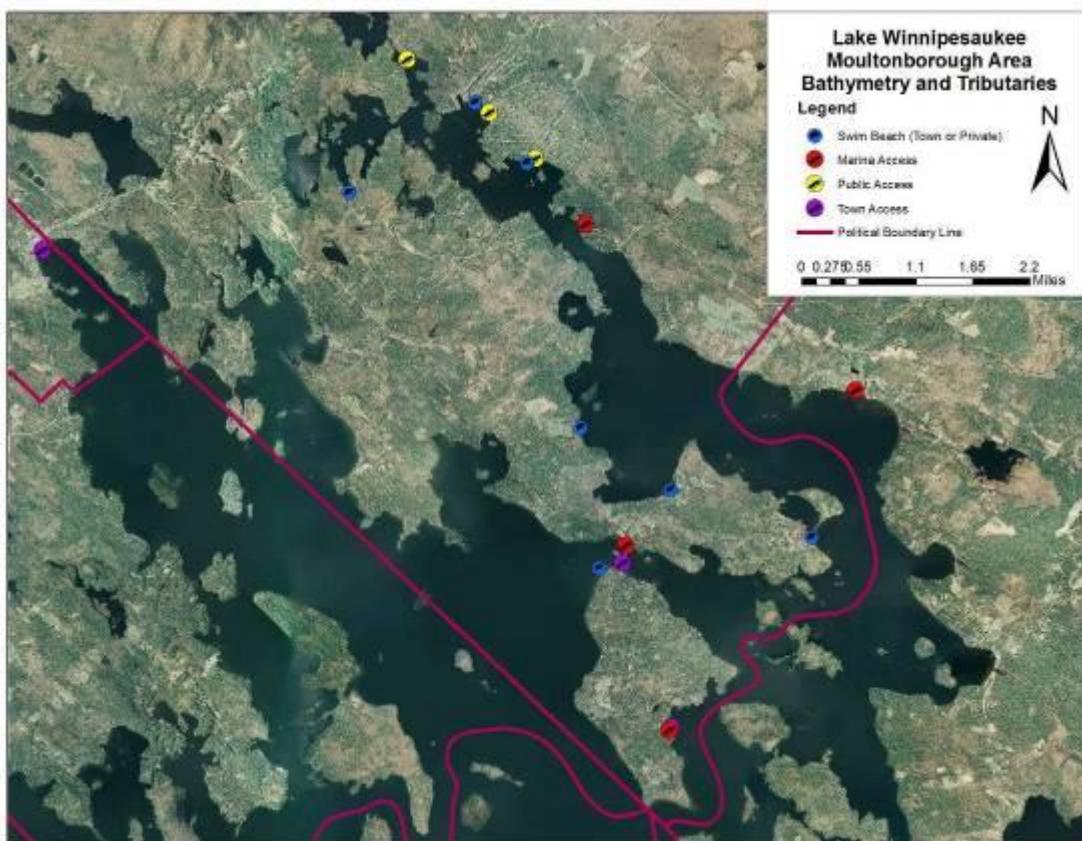
Figure 6: Public Access Sites, Swim Areas

Figure 6 shows the location of public access sites and swim beaches of particular interest/concern with regards to the milfoil infestation and control actions.
